John Mills & Associates

Property Inspection Report

111 Yellow Brick Road, Calgary, Alberta

Date of Inspection: 1/9/2014 Time: 12:00PM
Age of Home: 14 years old. Size: 1,959 sq.ft.
Weather: Overcast 2°C

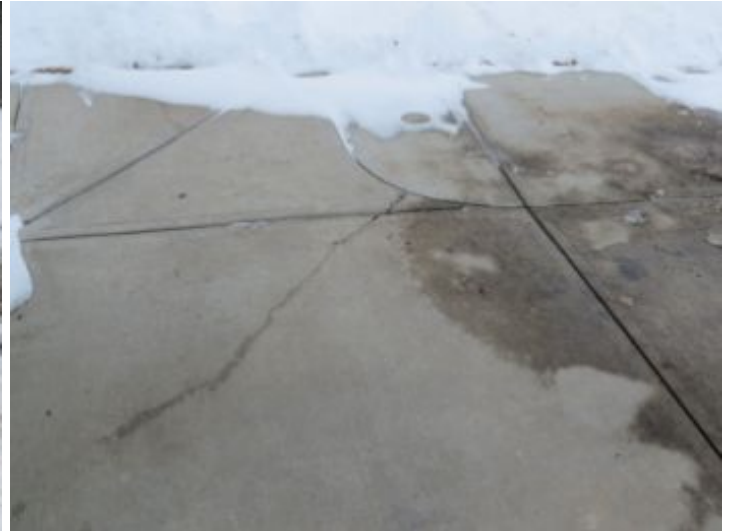
- At the time of inspection there was no major concerns with the original concrete driveway. Some expected cracks and spalling.
- Snow limited the driveway inspection.

Concrete cracks

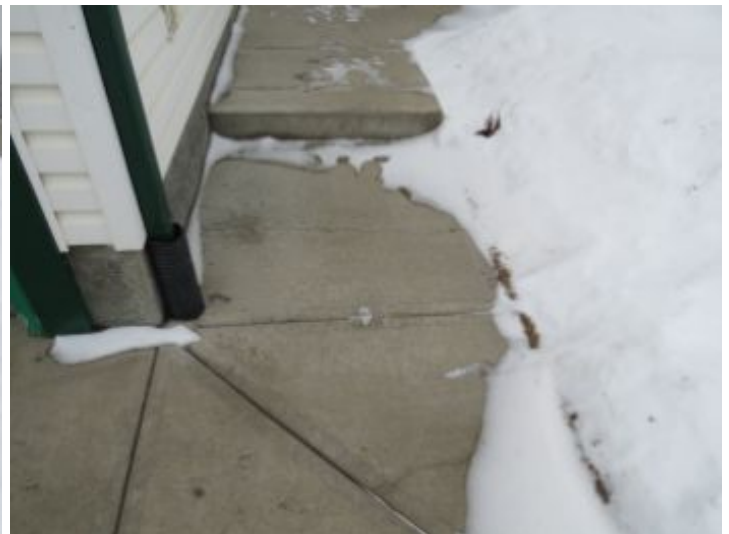
- At the time of inspection there was no major concerns with the concrete walkway (s). Some expected cracks.
- To avoid a tripping hazard, make concrete pavers level.
- Snow limited the walkway inspection.

Concrete cracks

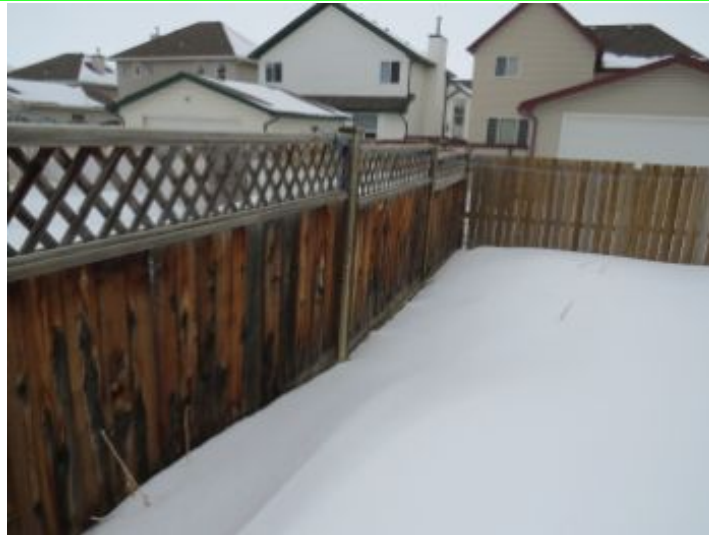
- Wood deterioration of the fence observed. Suggest repairs, paint or replacement.
- To avoid decay exterior wood must be maintained & painted on a regular bases.

Refinish & paint fence

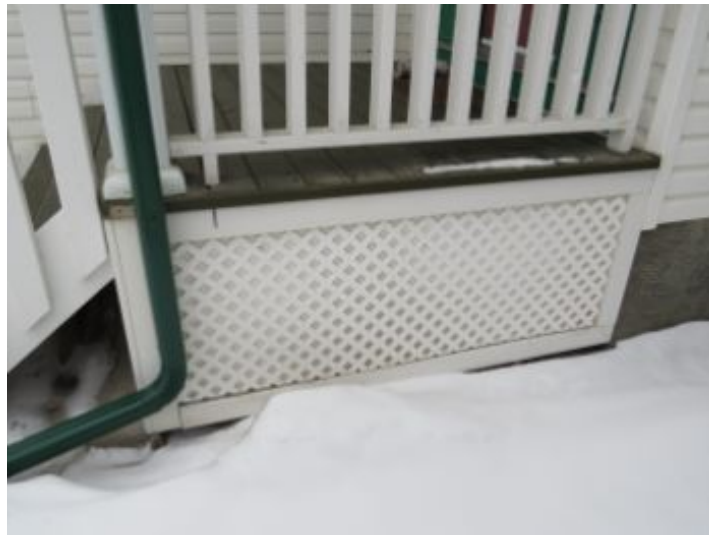
- The deck requires painting.
- There is no access to the underside of the deck for proper inspection or maintenance.
- There underside of the deck must be painted when the surface of the deck is painted.

No access to the underside

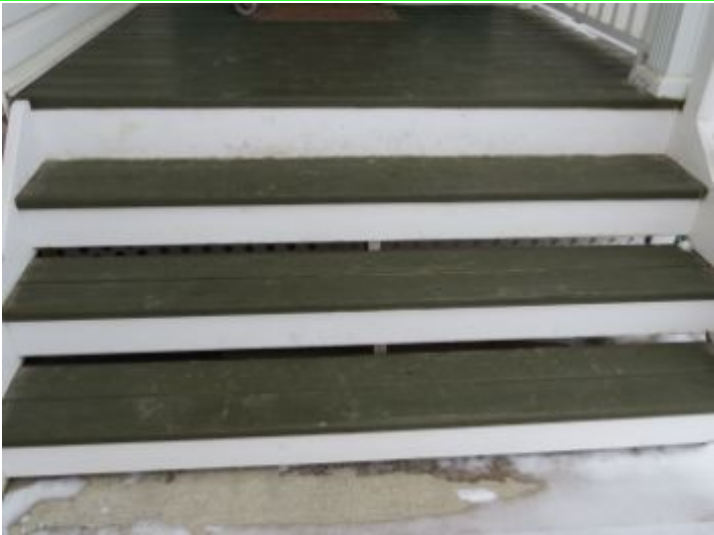
- The top & underside of the front deck steps & guard rail requires paint.

Refinish & paint

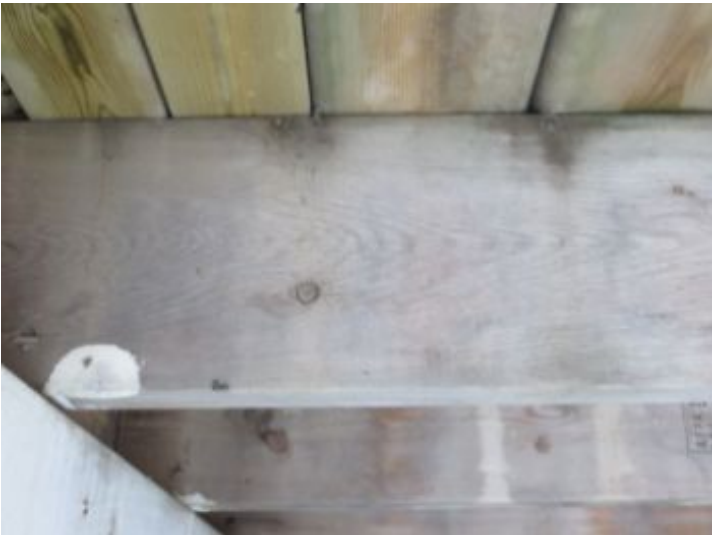
Observation & Recommendation:
• At some time a section of the deck was added. Snow limited the deck inspection & when the there is no snow the deck must be re - inspected & required repairs performed.

Refinish & paint

| Grounds | | |
|---|---|---|
| Page 9 Item: 9 | Rear/Side Deck & Patio. | <ul style="list-style-type: none"> At some time a section of the deck was added. Snow limited the deck inspection & when there is no snow the deck must be re-inspected & required repairs performed. |

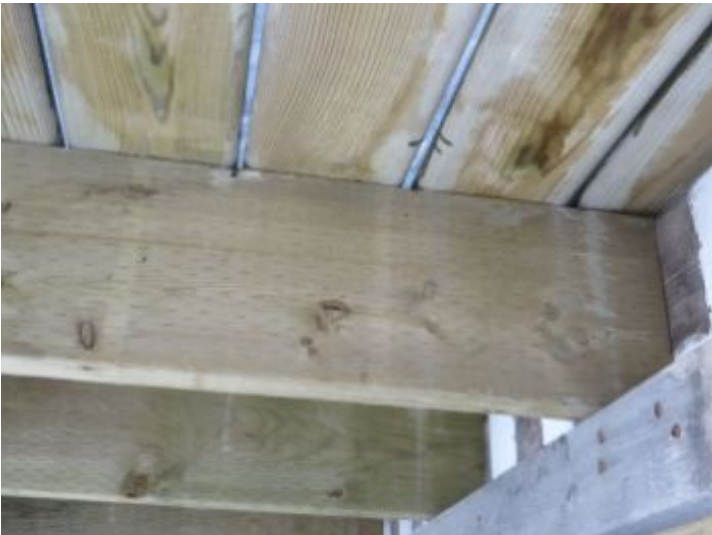
Section added to deck

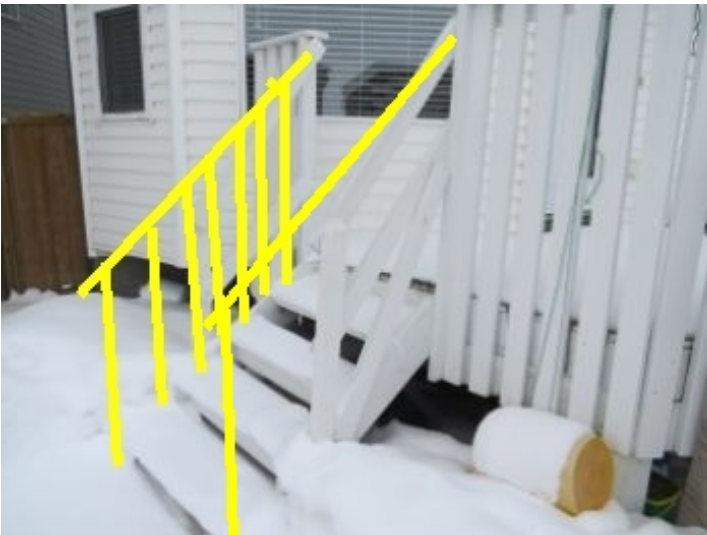
- The step(s) hand/guard rail does not meet code requirements & are not safe. Have a qualified carpenter investigate further & advise.
- The horizontal elements of the deck rail create a climbing hazard & are not safe & must be removed.

Properly construct hand/guard rail

| Grounds | | |
|---|---|---|
| Page 10 Item: 10 | Rear/Side Steps & Handrail. | <ul style="list-style-type: none"> The step(s) hand/guard rail does not meet code requirements & are not safe. Have a qualified carpenter investigate further & advise. The horizontal elements of the deck rail create a climbing hazard & are not safe & must be removed. |

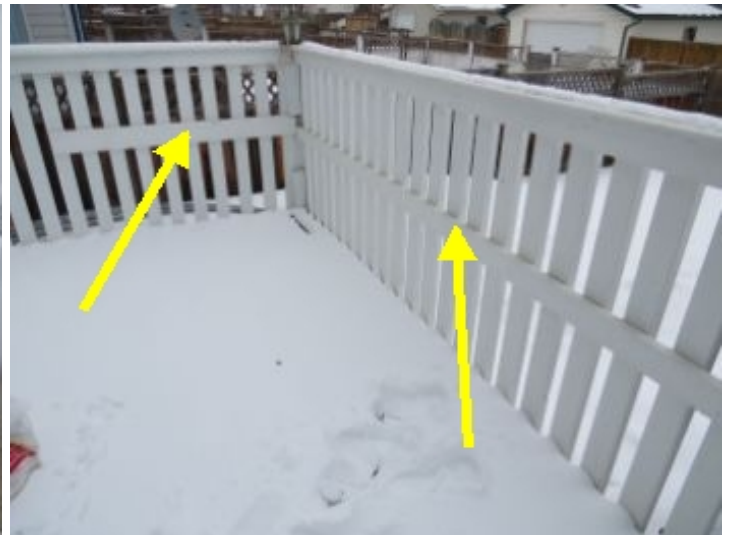
Rail is a climbing hazard

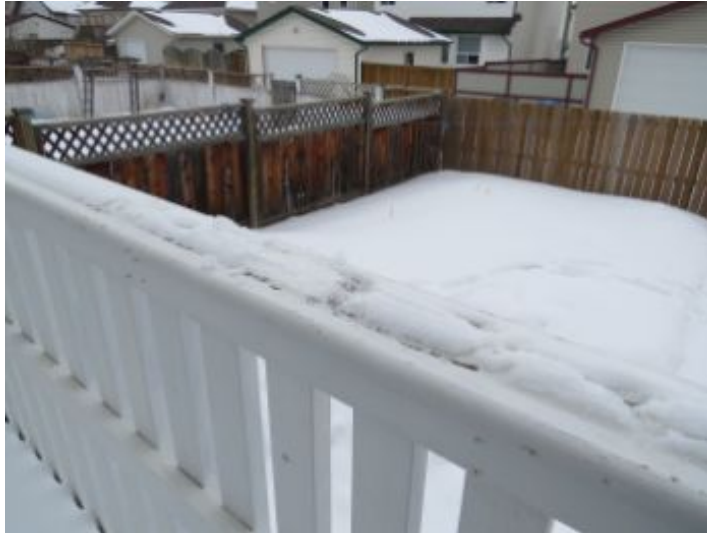
Refinish & paint

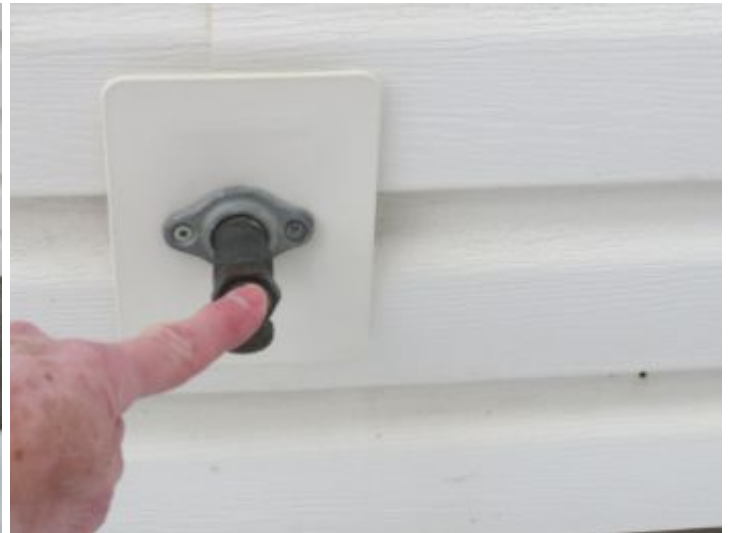
- There is no handle on the west exterior faucet.

No faucet lever

| Grounds | | |
|---|---|---|
| Page 11 Item: 11 | Exterior Faucet & Condition. | <ul style="list-style-type: none"> There is no handle on the west exterior faucet. |

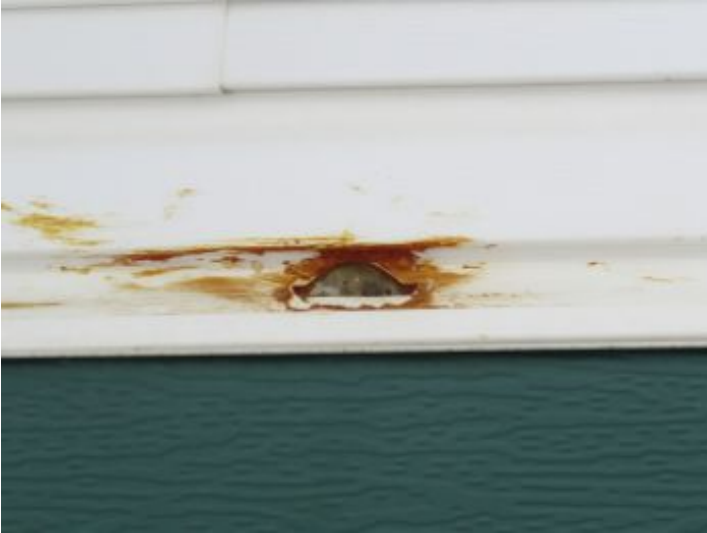
- The exterior finish can be washed & painted.
- At the time of inspection there was a number of siding damage/holes. To avoid water entering the structure, repair.

Repair damage

| Grounds | | |
|---|---|---|
| Page 14 Item: 2 | Exterior Finish Condition | <ul style="list-style-type: none"> At the time of inspection there was a number of siding damage/holes. To avoid water entering the structure, repair. |

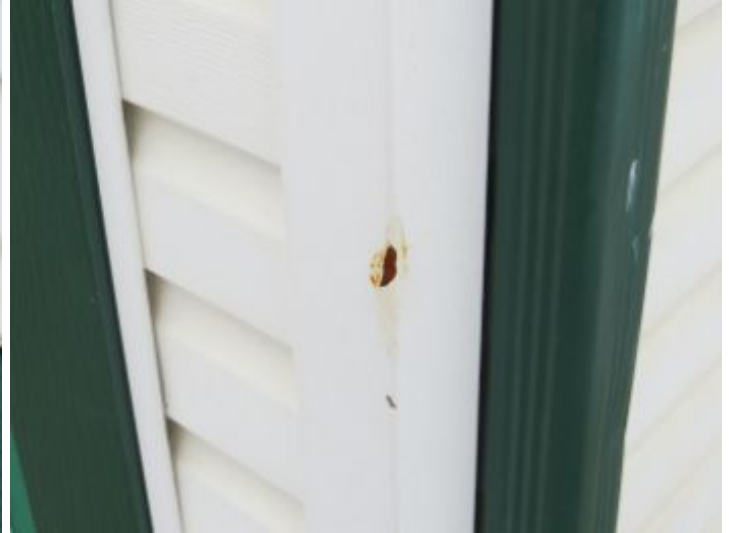
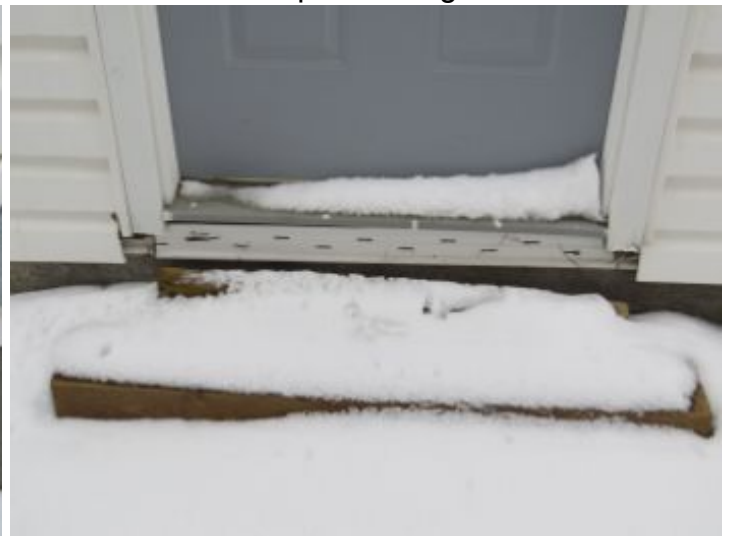
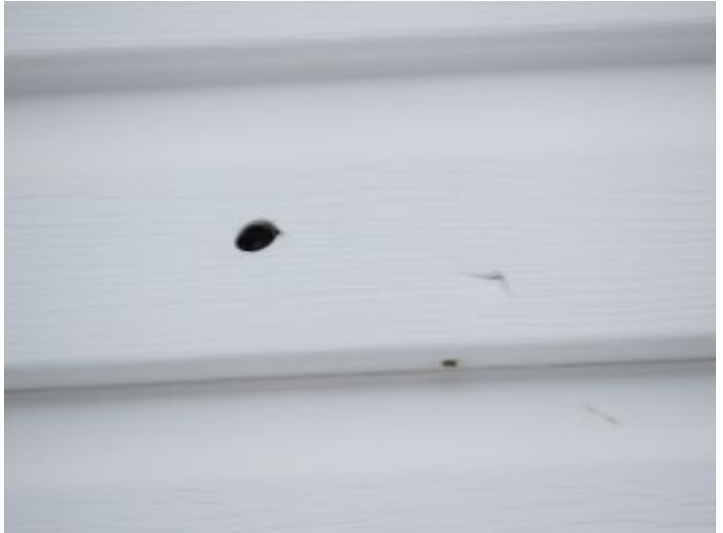
Repair damage

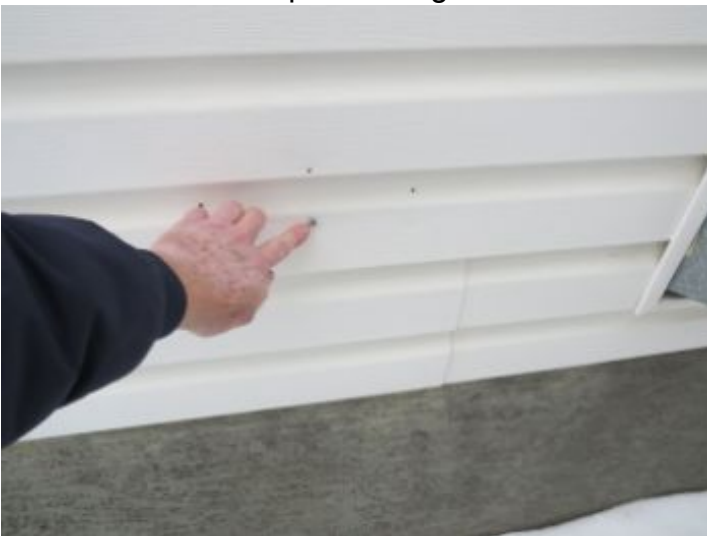
Repair damage

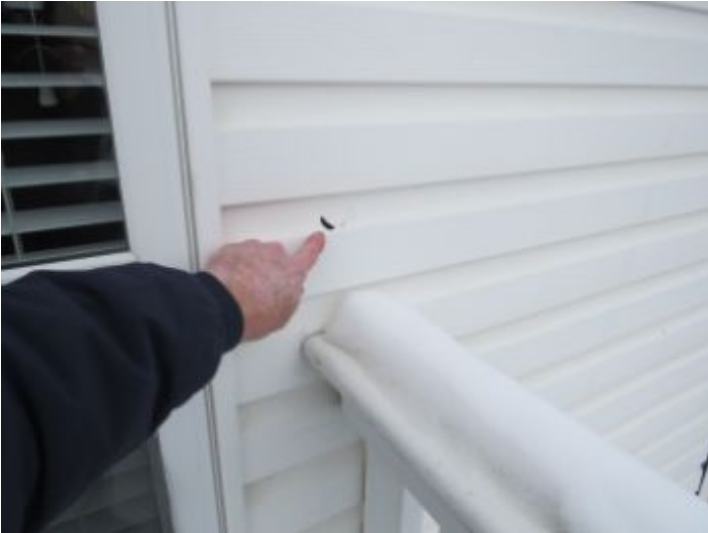
Repair damage

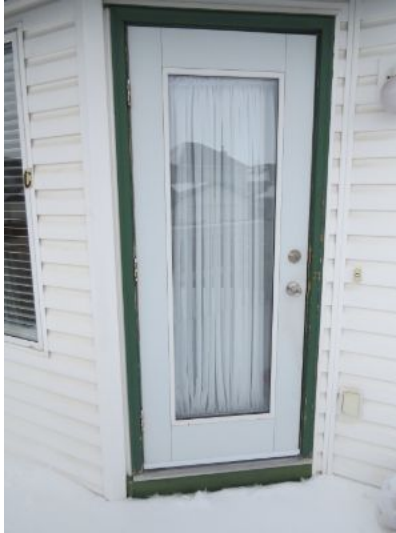
- The entrance door(s) needs re - finishing.
- The entrance door frame(s) need refinishing.
- It is recommended to re - key the exterior door locks.

Refinish & paint

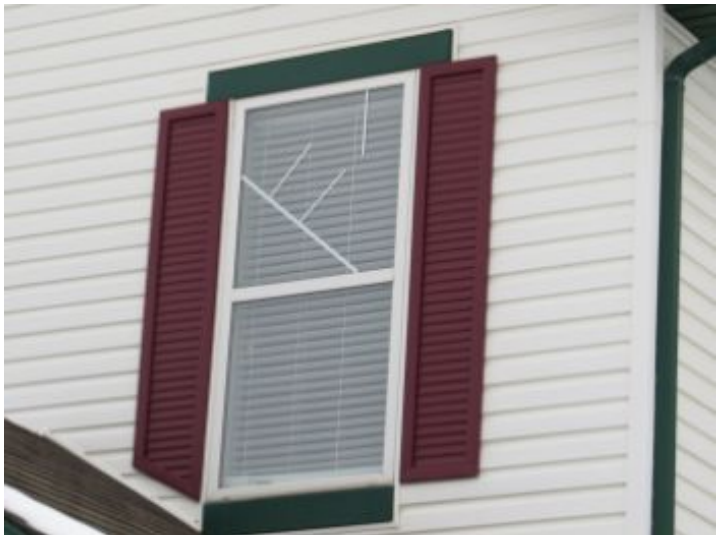
- At the time of inspection there are no major concerns with the vinyl windows.
- One window ornament bars are not properly installed. This can be repaired.

Window damage

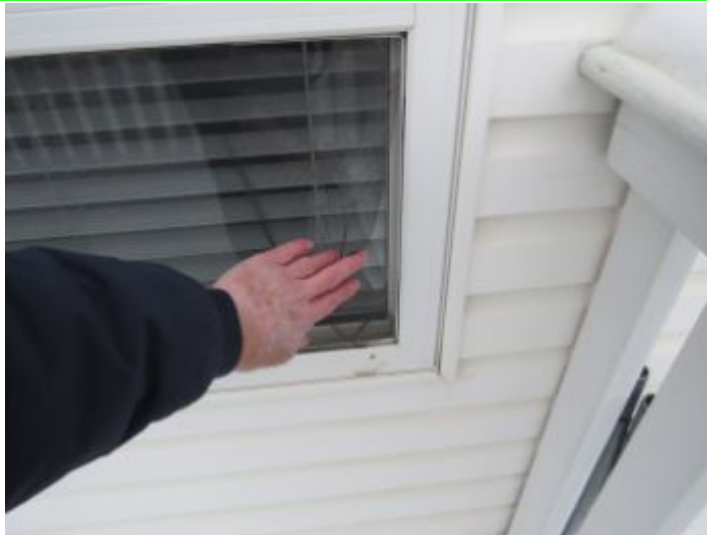
Damaged screens

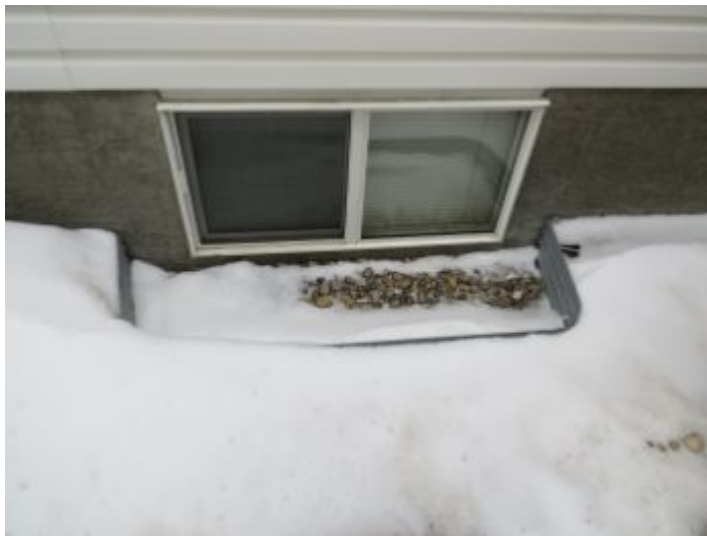
- The window well(s) must be kept clean & monitored for proper drainage.

Keep clean

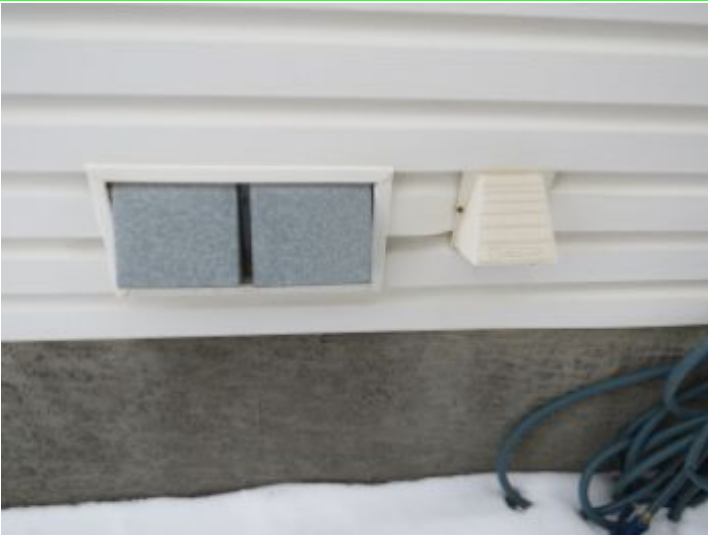
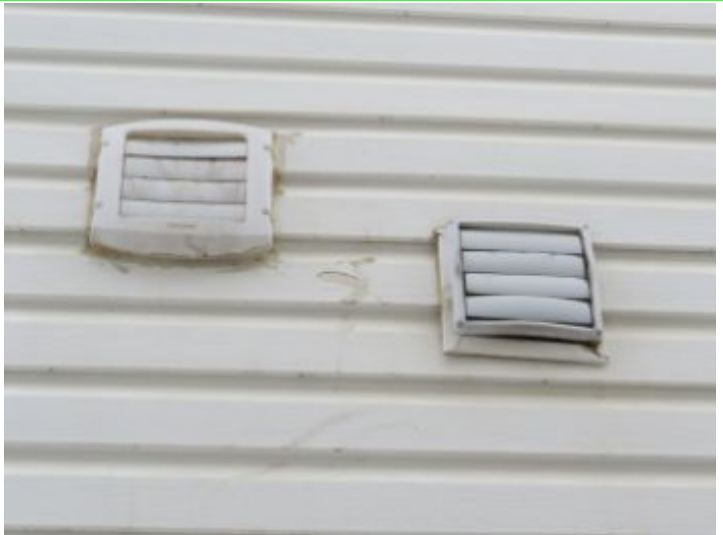
- Replace damaged vent cover(s).

- A stove top vent was added. The vent that is not used must be removed, the wall properly insulated & the siding repaired. Damage caused by water penetration at this location can not be seen.

Keep vents clean

| Grounds | | |
|---|---|---|
| Page 18 Item: 12 | Exterior Wall Vent Covers | <ul style="list-style-type: none"> Replace damaged vent cover(s). A stove top vent was added. The vent that is not used must be removed, the wall properly insulated & the siding repaired. Damage caused by water penetration at this location can not be seen. |

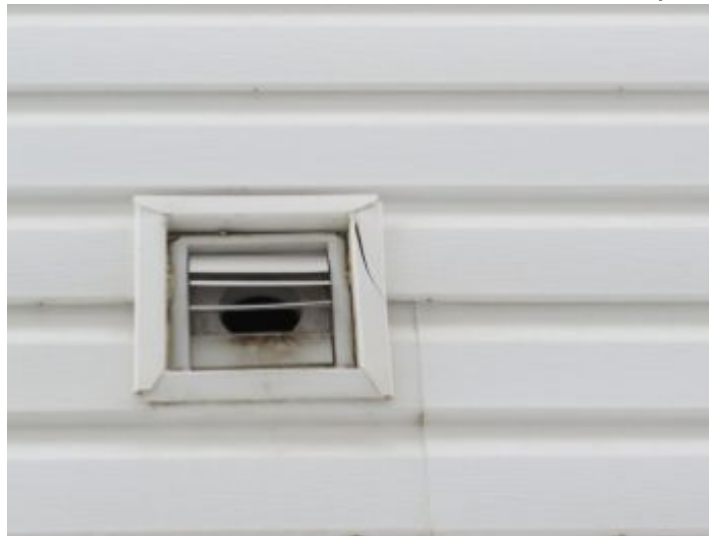
Repair damage

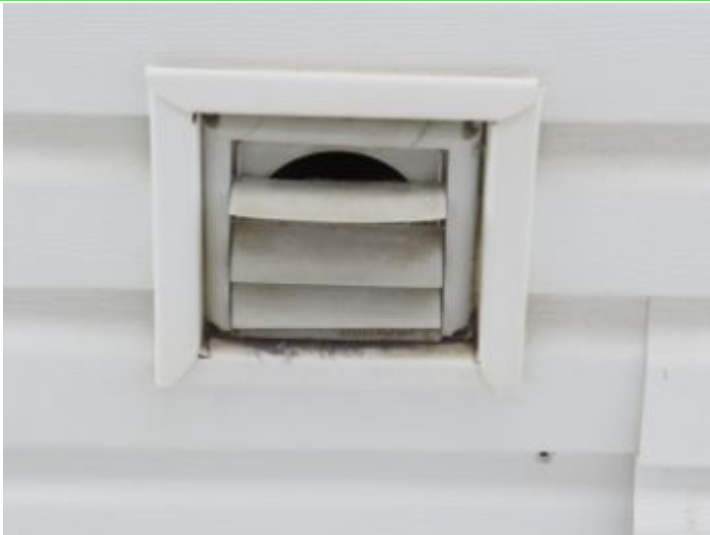
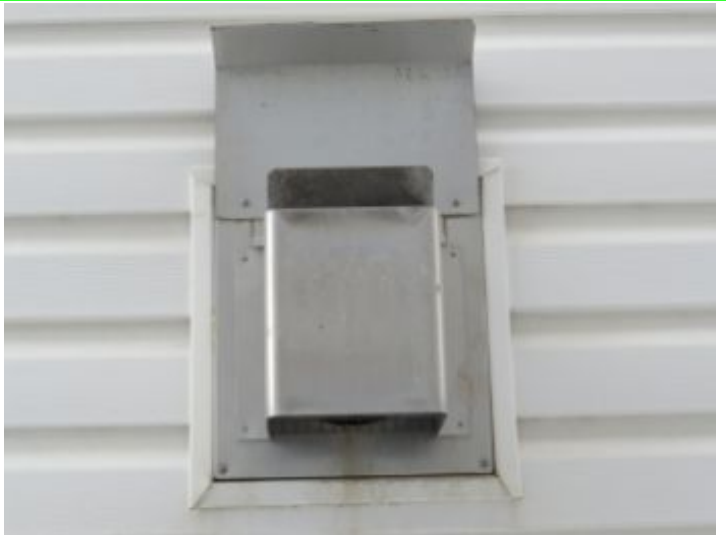
Repair damage

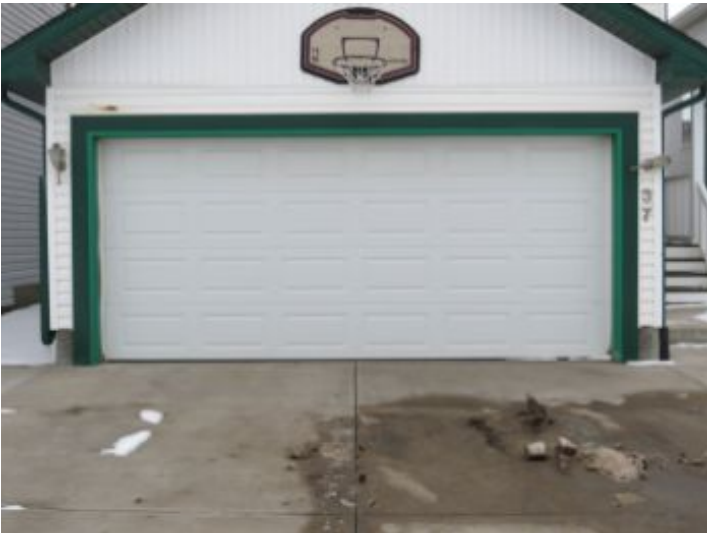
- At the time of inspection there was no major concerns with the double overhead metal clad door.
- The door frame requires refinishing/paint.
- The door weather stripping requires repair/replacement.

Repair weather stripping

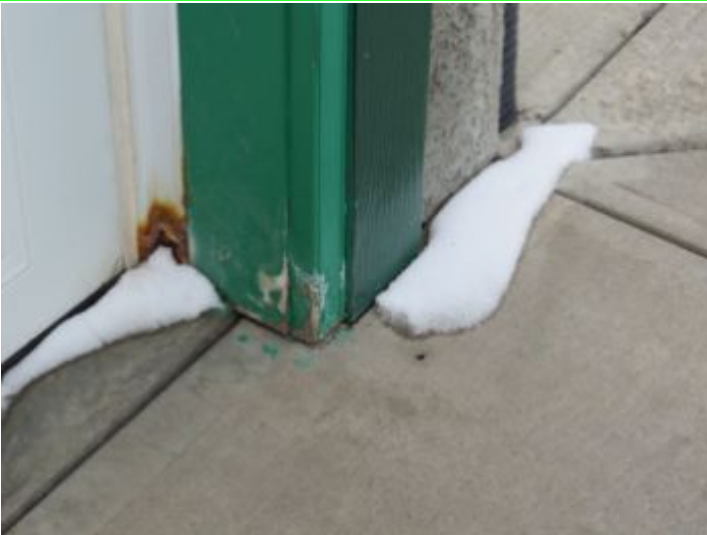
Refinish & paint

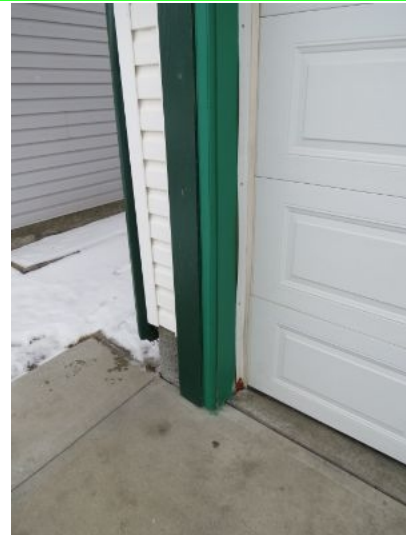
Repair/replace weather stripping

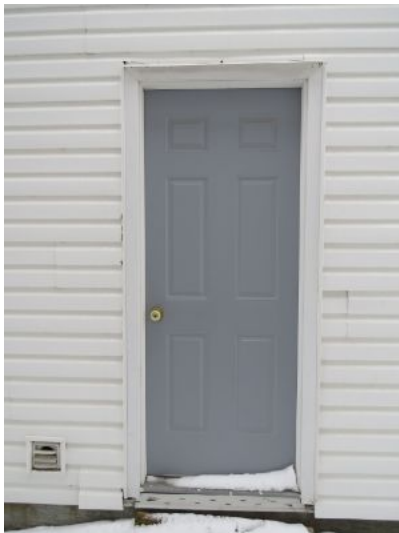
- The steps at the door to the exterior needs to be inspected further when there is no snow. To stop water entering the structure the exterior siding at this door requires repair.

Properly install

| Grounds | | |
|---|---|---|
| Page 22 Item: 6 | Garage Exterior Door, | <ul style="list-style-type: none"> The steps at the door to the exterior needs to be inspected further when there is no snow. To stop water entering the structure the exterior siding at this door requires repair. |

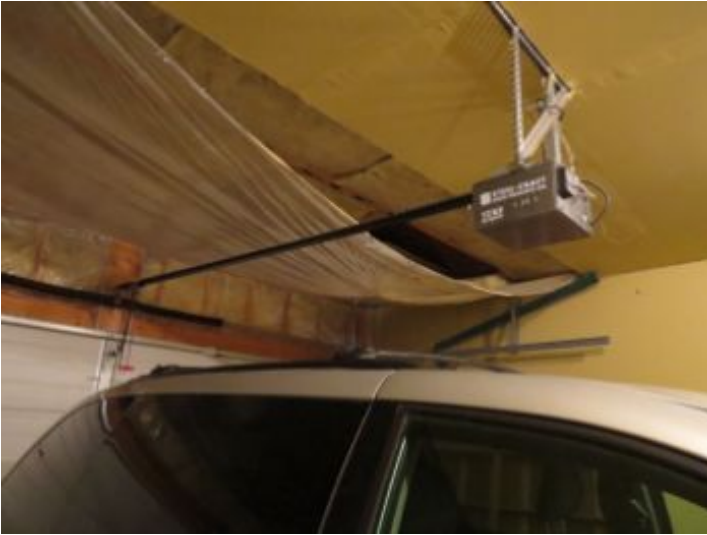
- **The insulation/vapour barrier is not properly installed & requires repair.**

Repair vapour barrier.

| Grounds | | |
|---|---|---|
| Page 23 Item: 9 | Interior Wall & Ceiling Type & Condition. | <ul style="list-style-type: none"> The insulation/vapour barrier is not properly installed & requires repair. |

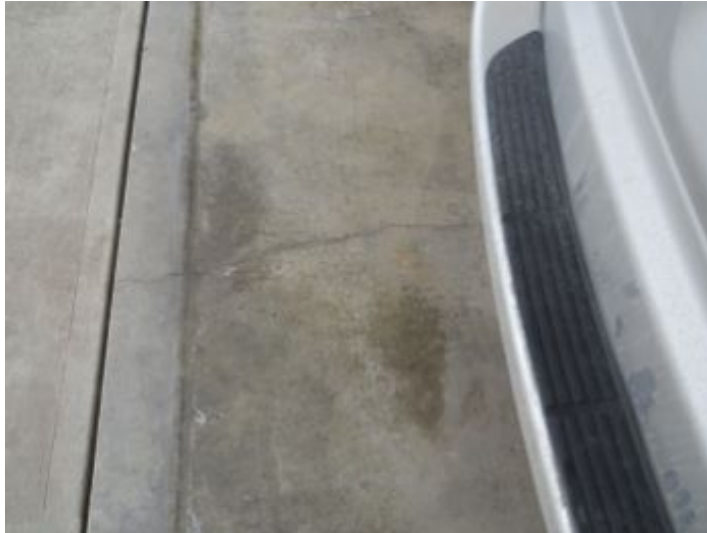
- At the time of inspection there was no major concerns with the concrete floor. Some none - structural cracking/spalling.

Concrete cracks

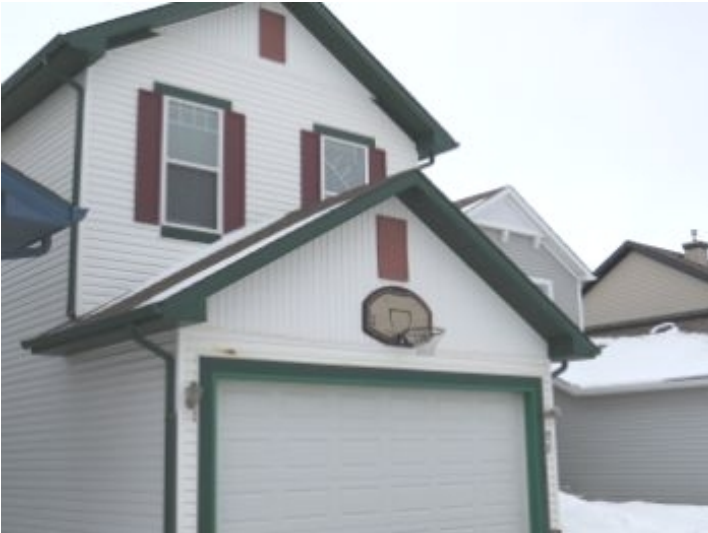
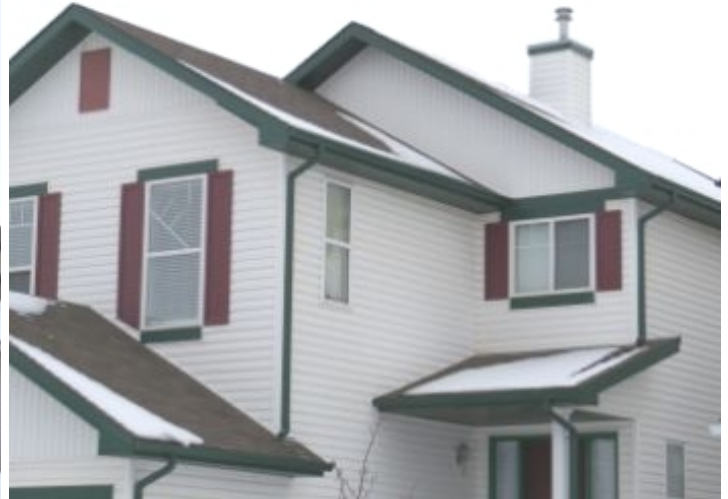
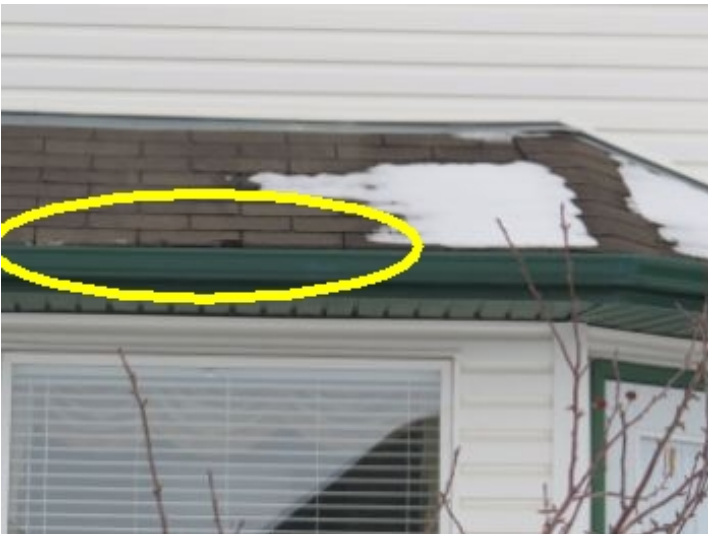
- Design life for this type of roof is 20 to 25 years if regular maintenance is under taken
- **Observed granular loss & shingle curl. Have a professional roof contractor investigate further & advise.**

Roof damage

| Page 26 Item: 1 | Roof Condition | • Observed granular loss & shingle curl. Have a professional roof contractor investigate further & advise. |

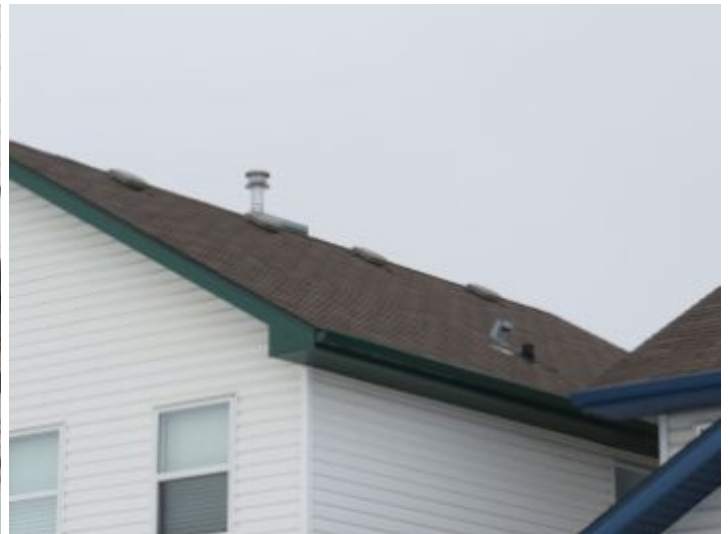
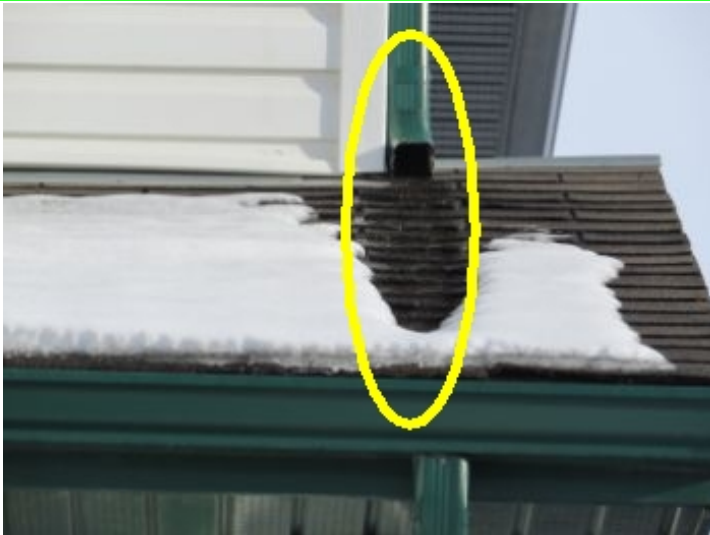
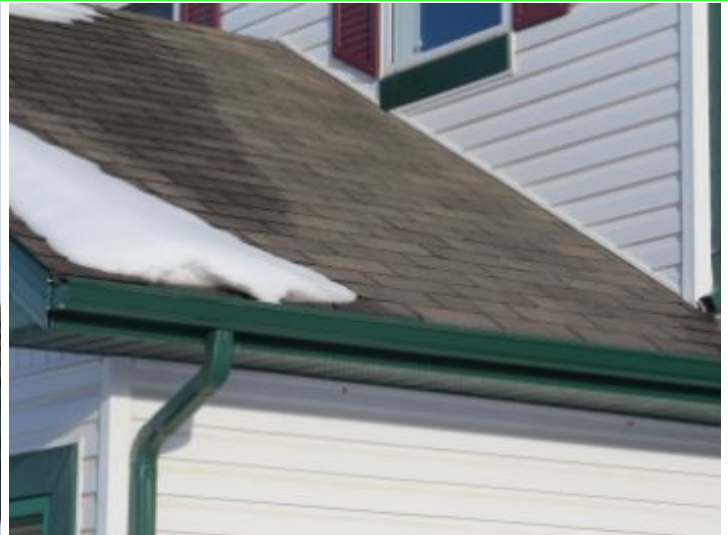
Roof damage

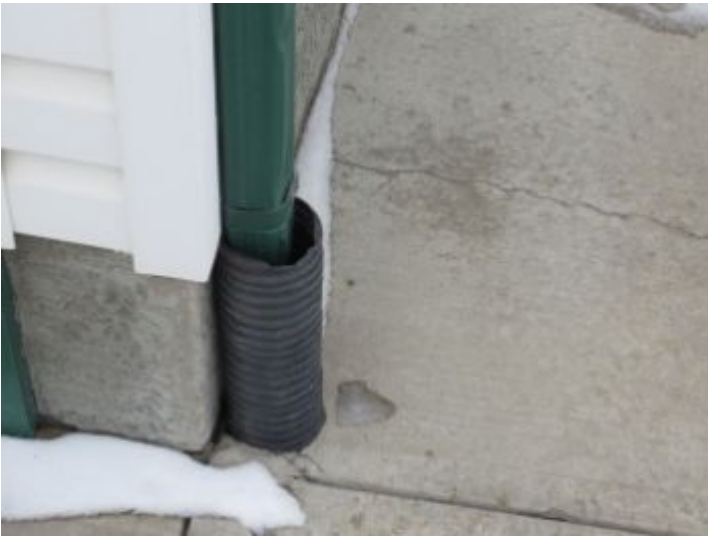
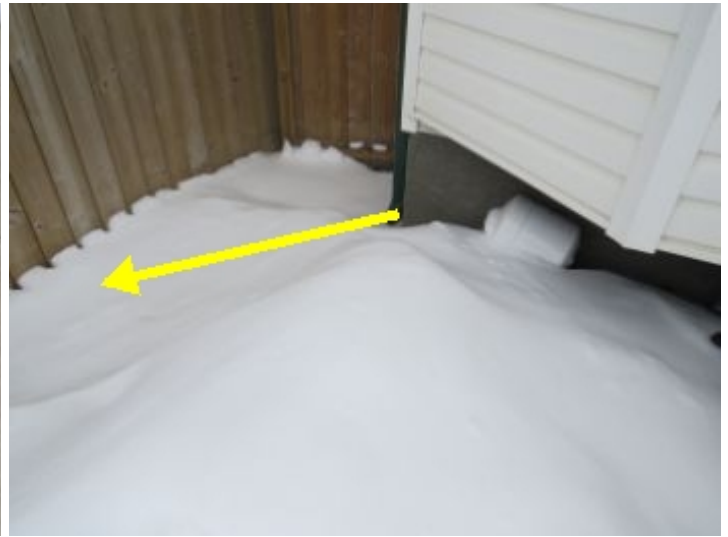
- The gutters must be cleaned on a regular bases to stop water entering the building from the gutters.
- Insure that down pipe(s) into the ground are kept clean & are monitored for proper drainage.
- To stop water entering the building foundations, 4 to 6 foot down pipe extensions, directing water away from the foundations must be installed & used.

Keep clean

Extensions must be used

| Page 28 Item: 6 | Gutter & Downpipe Type & Condition. | • To stop water entering the building foundations, 4 to 6 foot down pipe extensions, directing water away from the foundations must be installed & used. |

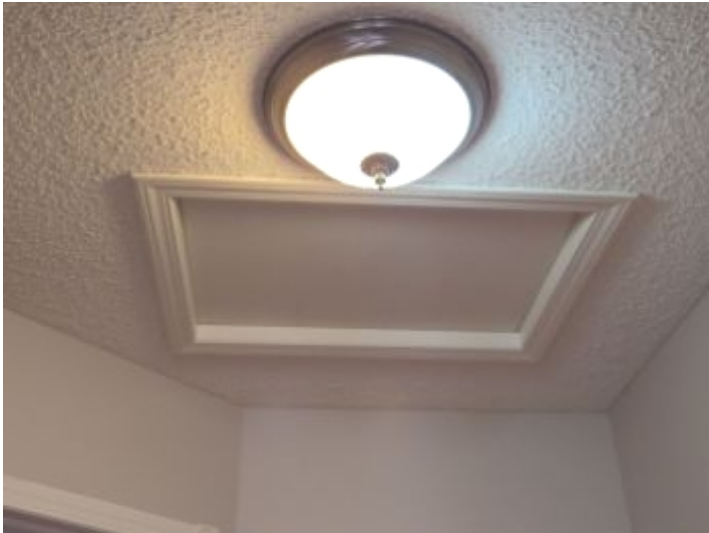
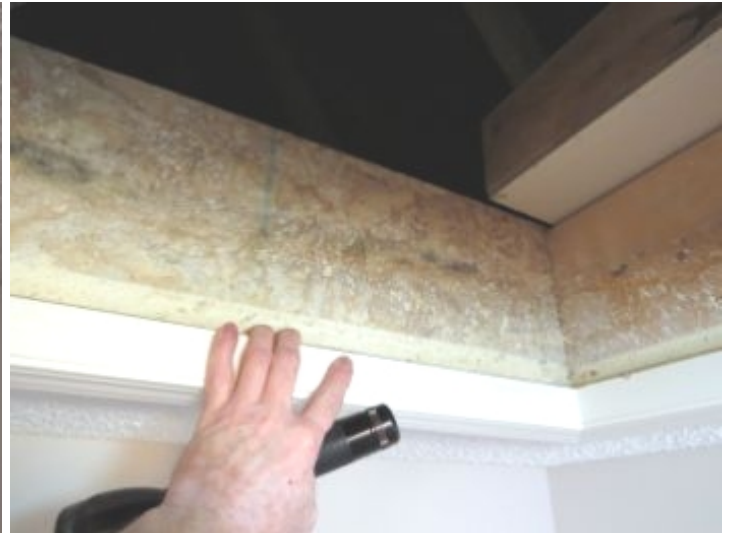
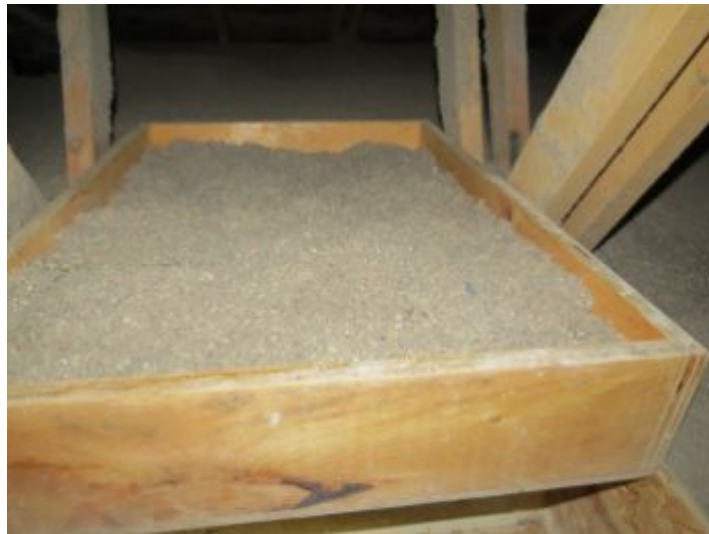
- Drop down hatch.
- Located at the upper floor hallway.
- To stop insulation falling from the attic. Install a 12 - inch plywood collar on the upper side of the hatch.
- To retain heat, save energy costs and make the dwelling more comfortable, glue at least eight inches of rigid insulation onto the attic hatch.
- To retain heat, save energy costs and make the dwelling more comfortable install new weather stripping onto the attic hatch lip.

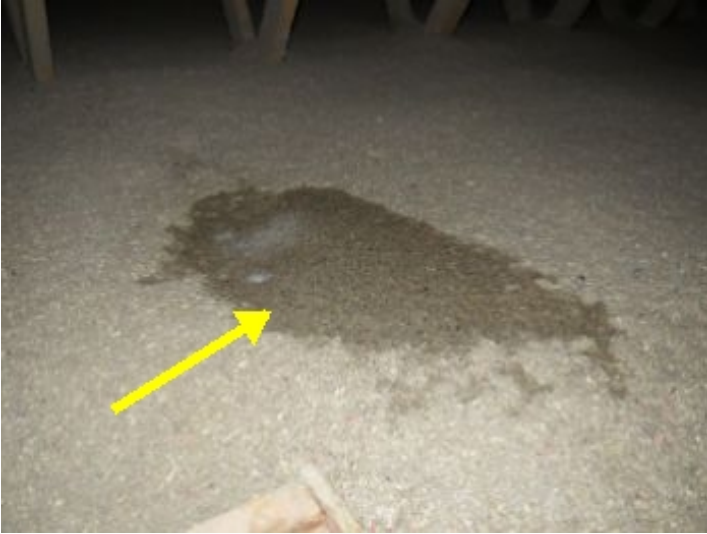
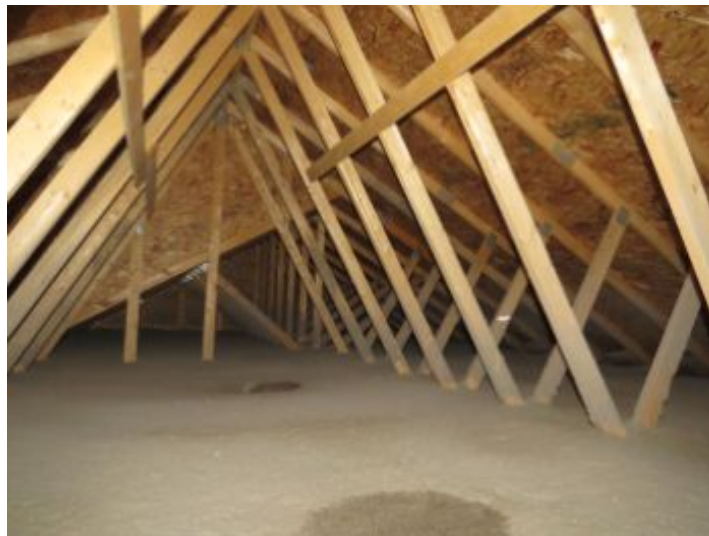
Moisture

- Dimensional lumber trusses, with wood sheathing.
- At the time of inspection there was no structural damage observed.
- **Water penetration observed (wet insulation) through the roof air vents. This could be caused by melting snow. Increase insulation in the attic to reduce heat loss into the attic which melts the snow. Consult with a roof contractor as to possible changes (location/style) of the roof vents.**

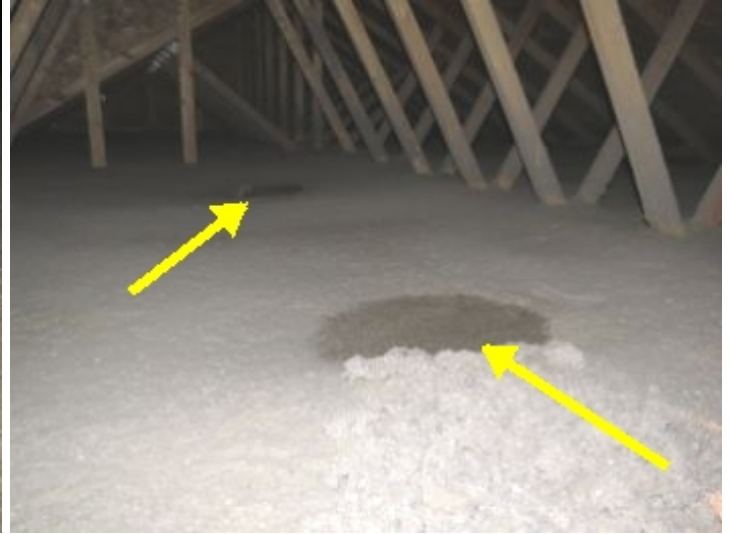
Moisture

| Page 32 Item: 3 | Roof Structure | • Water penetration observed (wet insulation) through the roof air vents. This could be caused by melting snow. Increase insulation in the attic to reduce heat loss into the attic which melts the snow. Consult with a roof contractor as to possible changes (location/style) of the roof vents. |

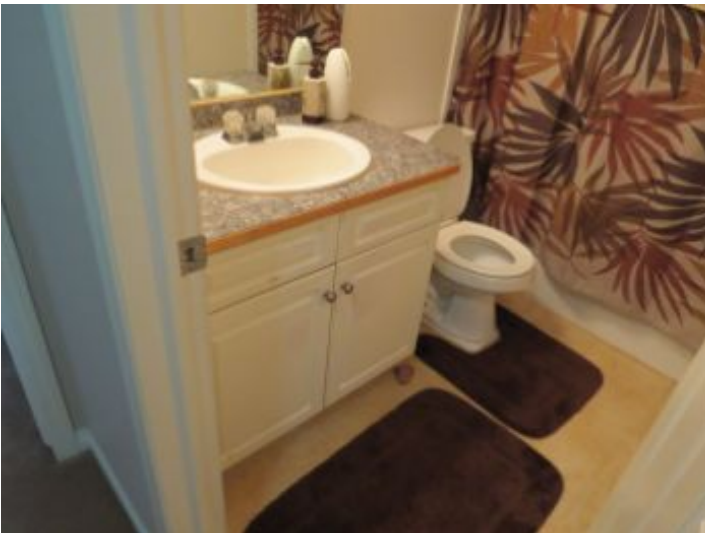
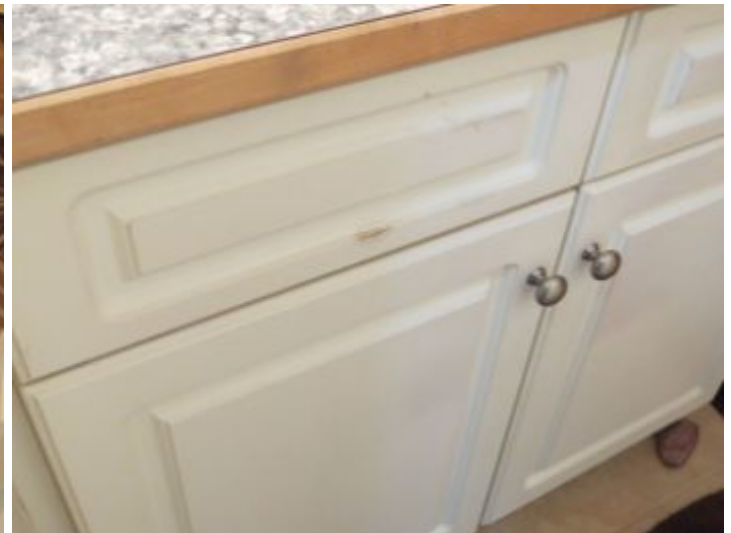
Blemish

- The cabinets requires some repair & cleaning.

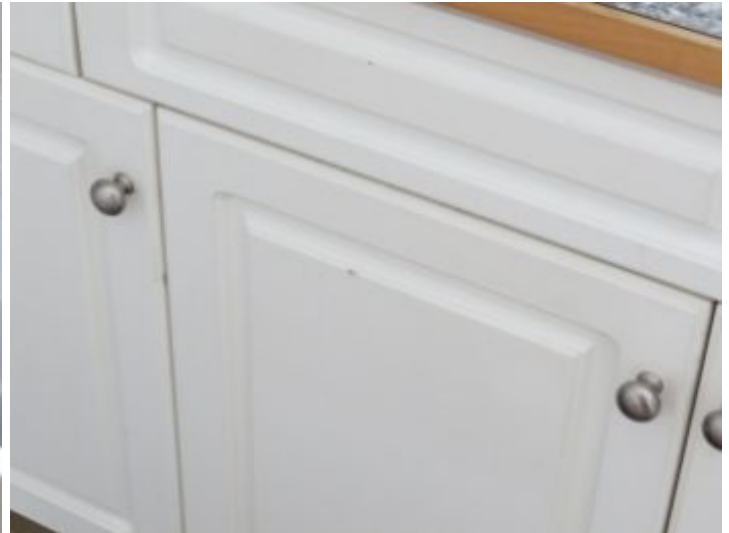
Blemish

- The cabinets requires some repair & cleaning.

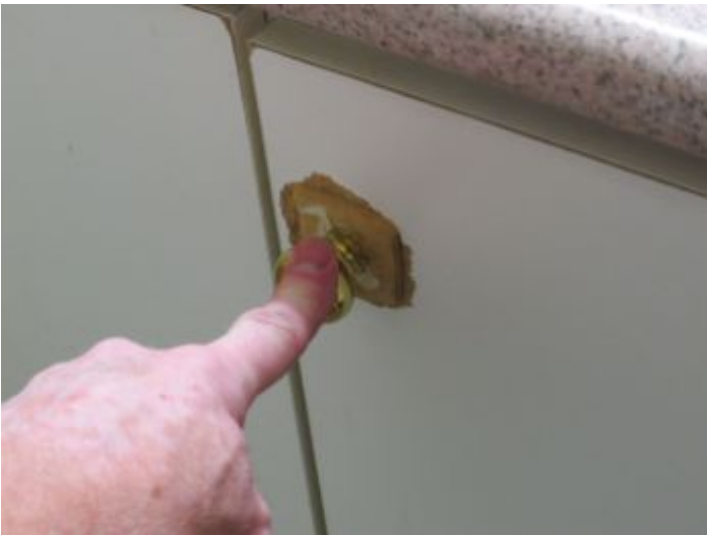
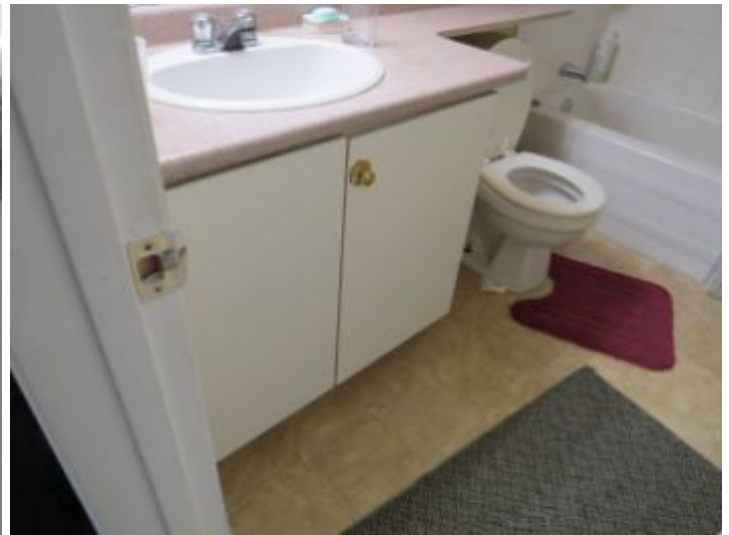
Repair damage

- The cabinets requires some repair & cleaning.

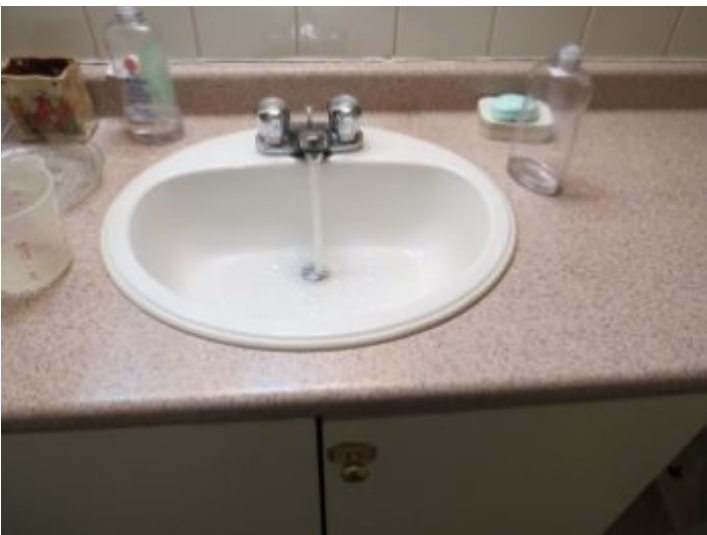
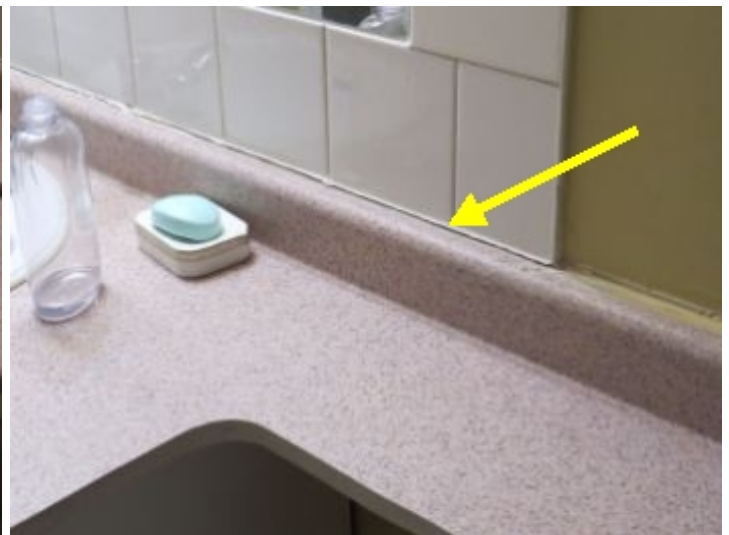
Repair

- At the time of inspection there was no concerns with the vanity sink(s).
- At the time of inspection there was no major concerns with the sink faucets.
- To improve the faucet water supply keep the aerator clean.

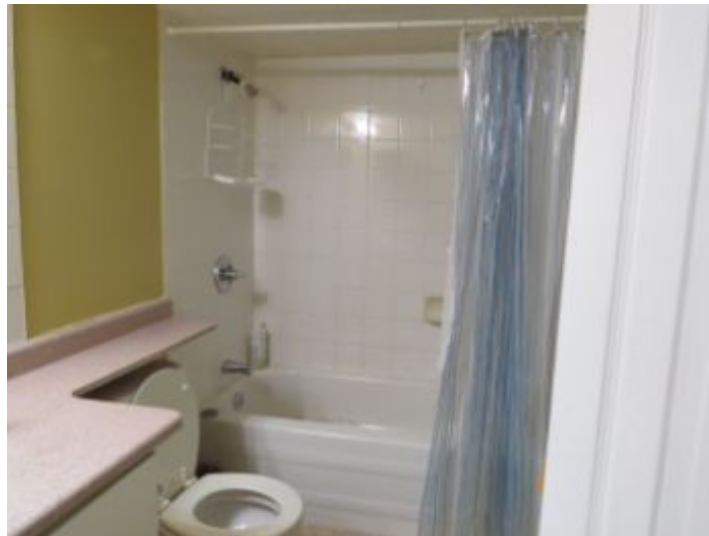
- The enclosure caulking needs to be replaced.
- To stop moisture penetration in the walls tiled enclosures must be kept dry, caulking & sealer maintained.

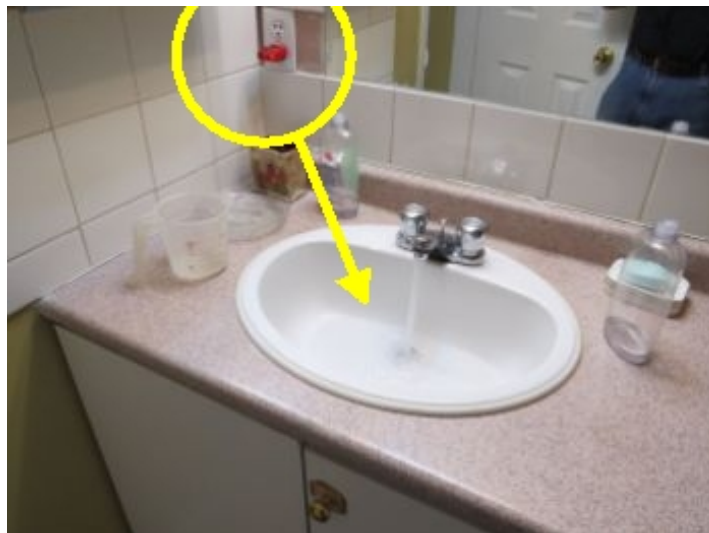
Not G.F.C.I. protected

- The electrical wall outlet is not G.F.C.I. protected. As a life safety concern replace with a GFCI protected wall outlet.
