John Mills & Associates

Property Inspection Report

111 Yellow Brick Road, Calgary, Alberta

Date of Inspection: 1/9/2014 Time: 12:00PM
Age of Home: 14 years old. Size: 1,959 sq.ft.
Weather: Overcast 2°C

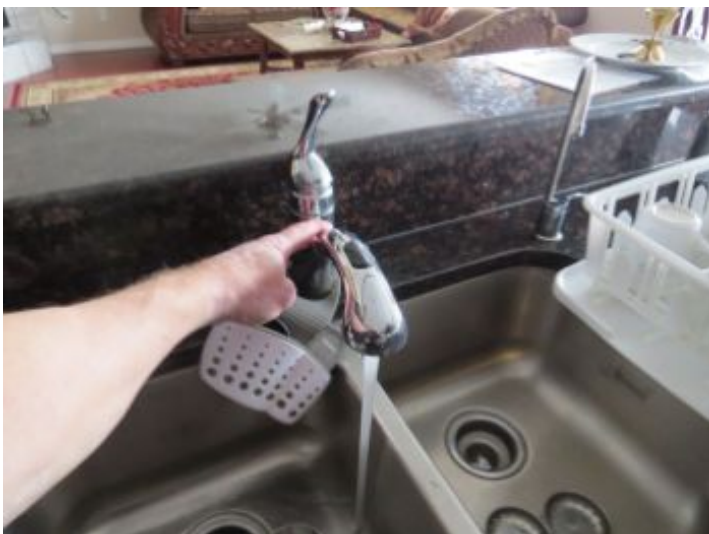
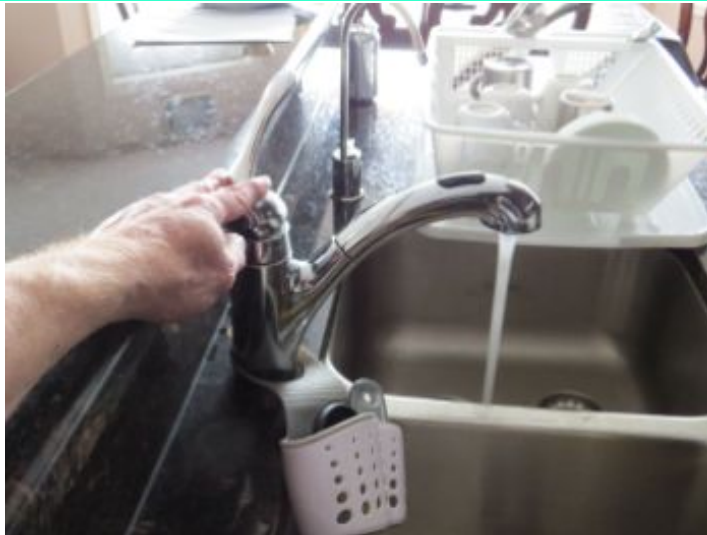
Loose

- At the time of inspection there was no concern with the kitchen sink.
- To improve the faucet water supply keep the faucet aerator clean.
- The sink faucet is loose & is too small (low) to operate properly. Have a qualified plumber properly install a taller faucet.

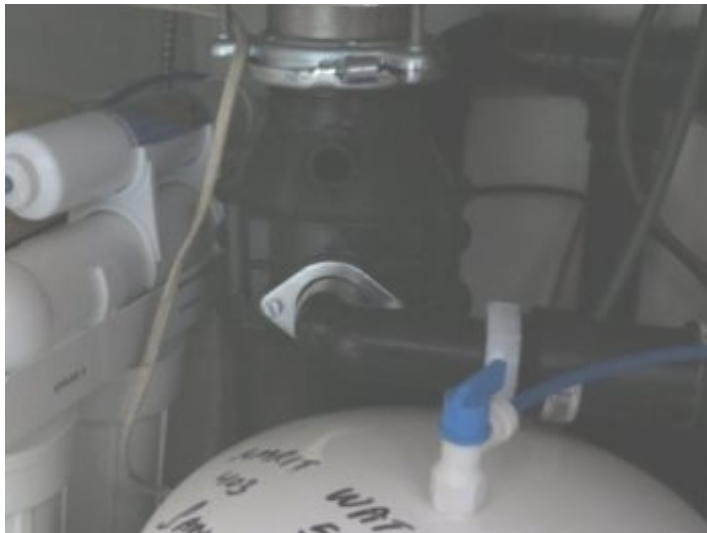
Does not function

- The operating efficiency or life expectancy of the appliance cannot warranted.
- The disposal unit operates with a "strained" noise. Have a qualified technician investigate further & advise.

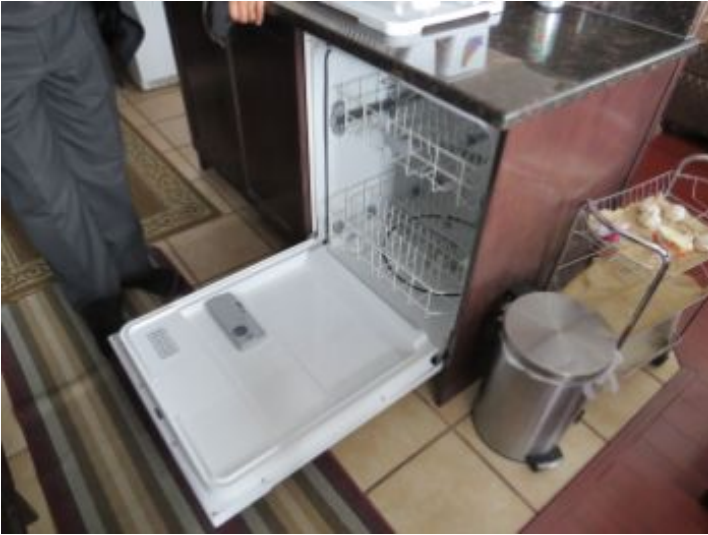
Door spring does not function

- At the time of inspection the dishwasher functioned.
- The operating efficiency or life expectancy of the appliance cannot warranted.
- The access panel below the door is not installed.
- The door spring did not function properly. Service or replace the unit.

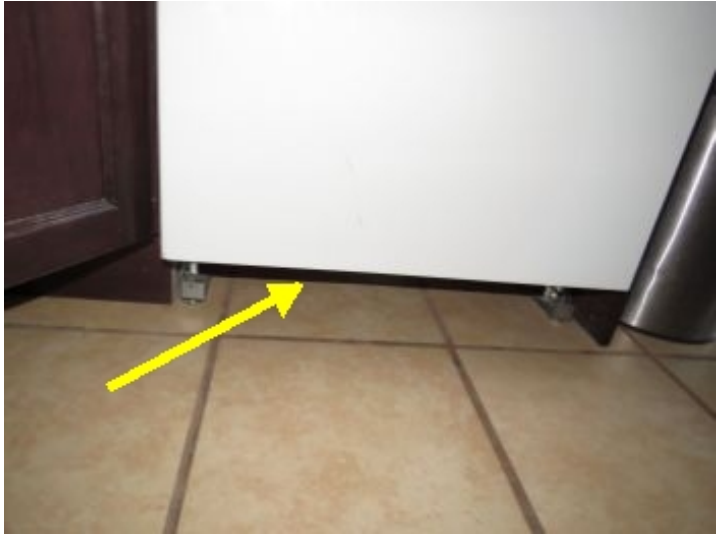
No bottom skirt

| Page 56 Item: 7 | Dishwasher | • The access panel below the door is not installed. • The door spring did not function properly. Service or replace the unit. |

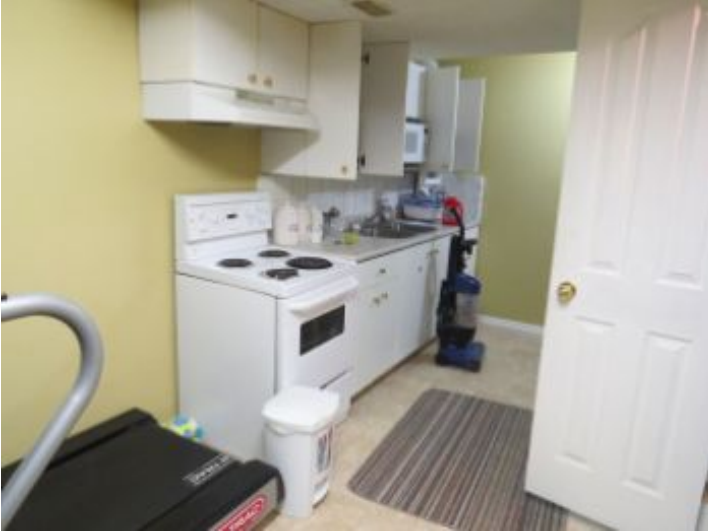
- At the time of inspection repair of the cabinets is required.
- It seems the kitchen was installed without a building permit. Permits for this type installation is required.

Not completed

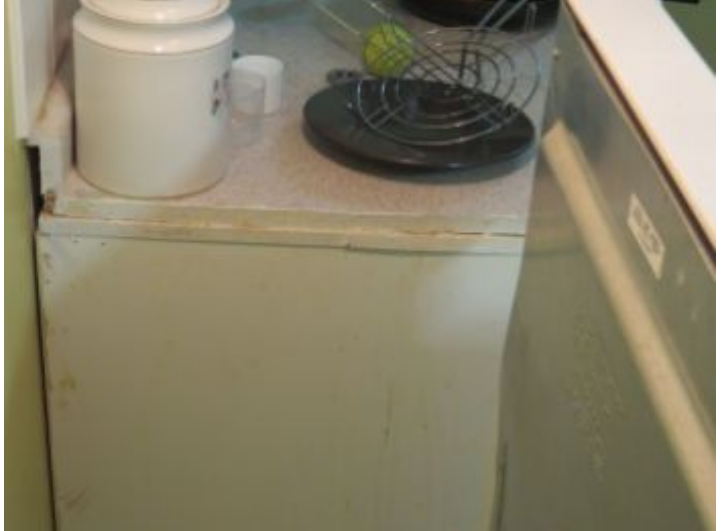
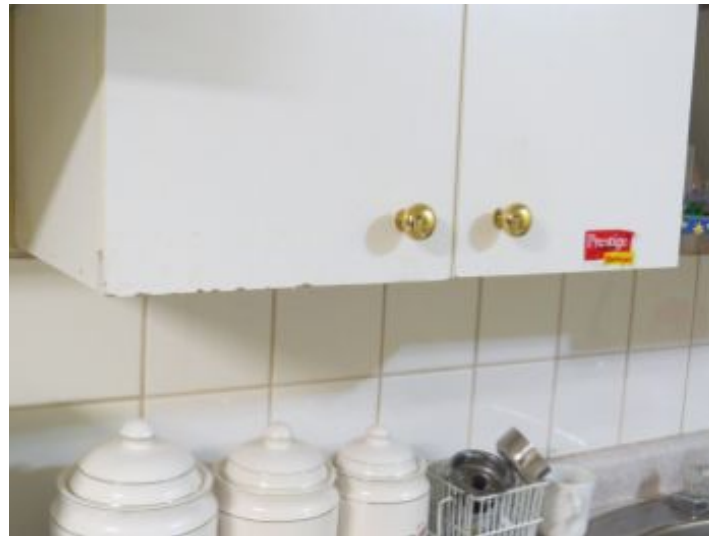
Damage

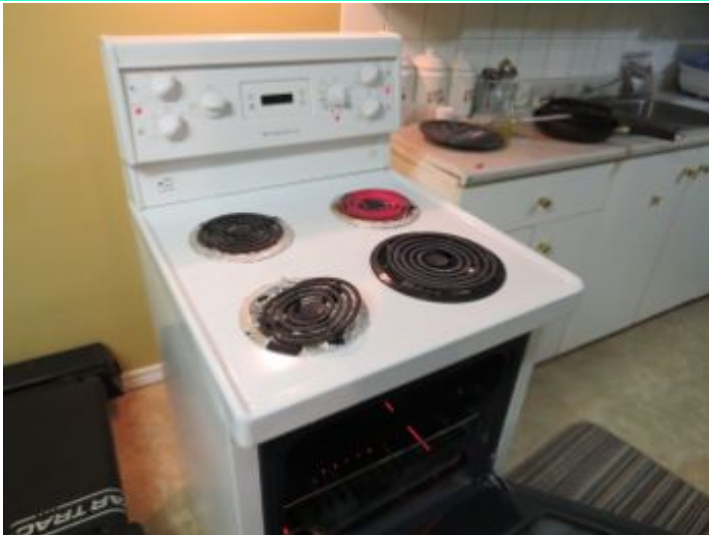
- The operating efficiency or life expectancy of the appliances cannot warranted.
- A number of stove top burners did not function.

Not all burners function

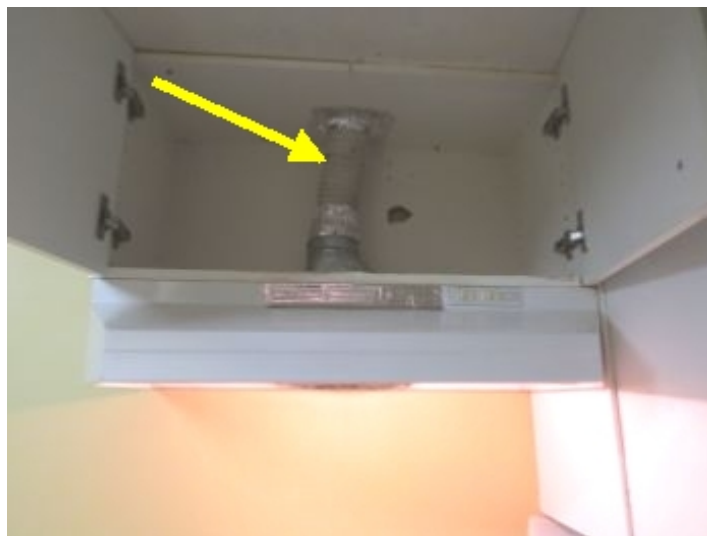
- Exterior exhausting stove top exhaust fan.
- The operating efficiency or life expectancy of the appliances cannot warranted.
- The vent pipe to the exterior is plastic & not the correct size. As a life safety concern (fire hazard) have a qualified sheet metal trades person replace the vent pipe with metal pipe of the correct size.

Vent must be metal & correct size

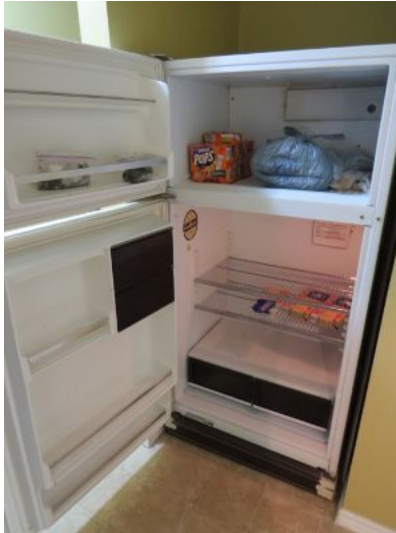
- At the time of inspection the refrigerator functioned.
- The operating efficiency or life expectancy of the appliances cannot warranted.
- The refrigerator is an older unit. Budget to replace.

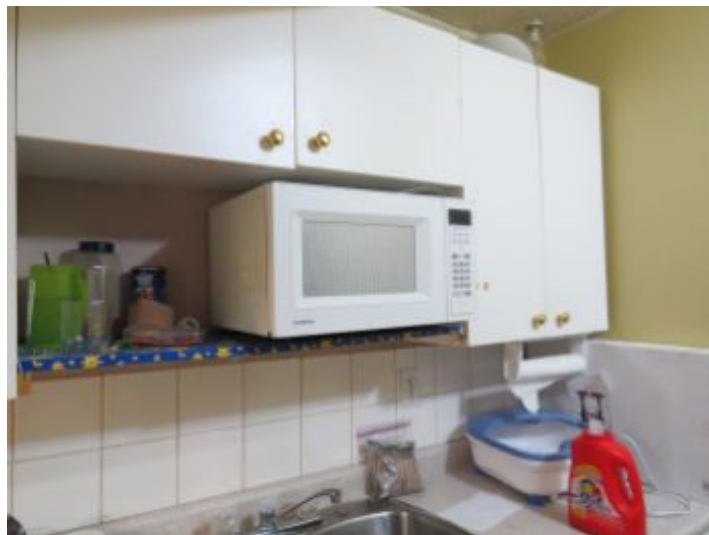
- There is no electrical outlet at the rear of the unit for proper installation.

No outlet for unit

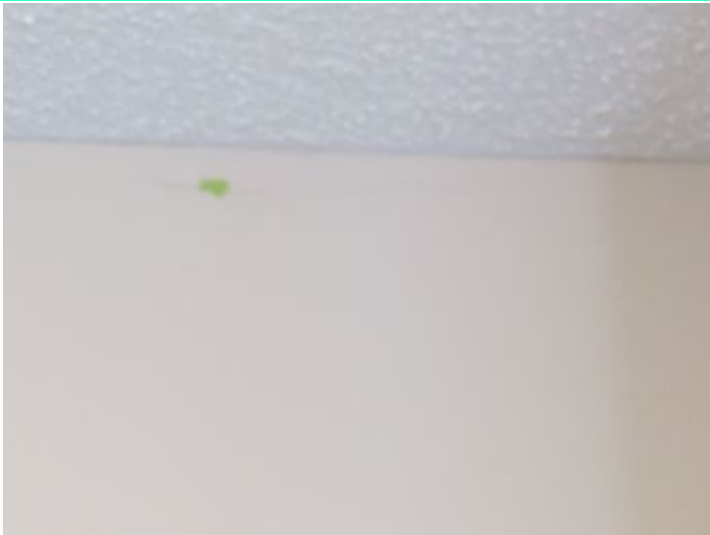
- Stored personal items & furnishings limited a complete wall and floor inspection.
- Expect further wall damage when the building is empty of furnishings.
- **There is extensive wall blemishes/damage that requires repair & repainting.**

Wall blemish

| Page 65 Item: 2 | Interior Wall type & Condition. | • There is extensive wall blemishes/damage that requires repair & repainting. |

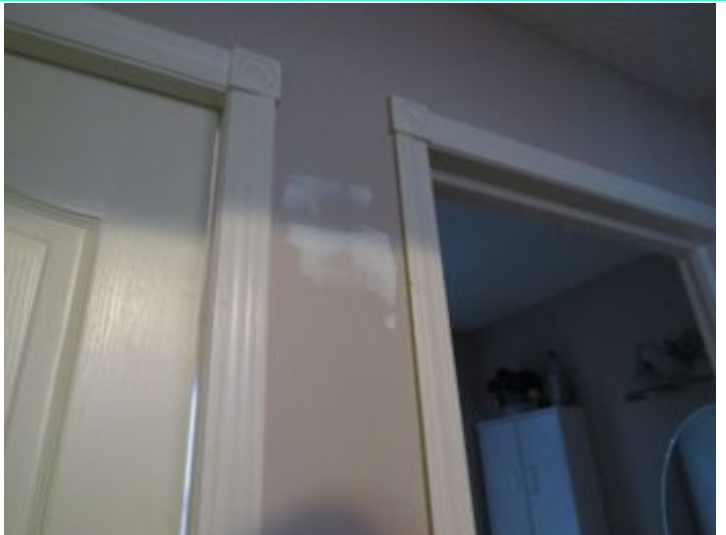
Wall blemish

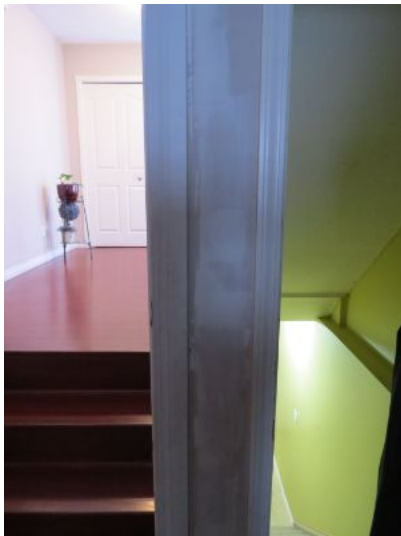
Wall blemish

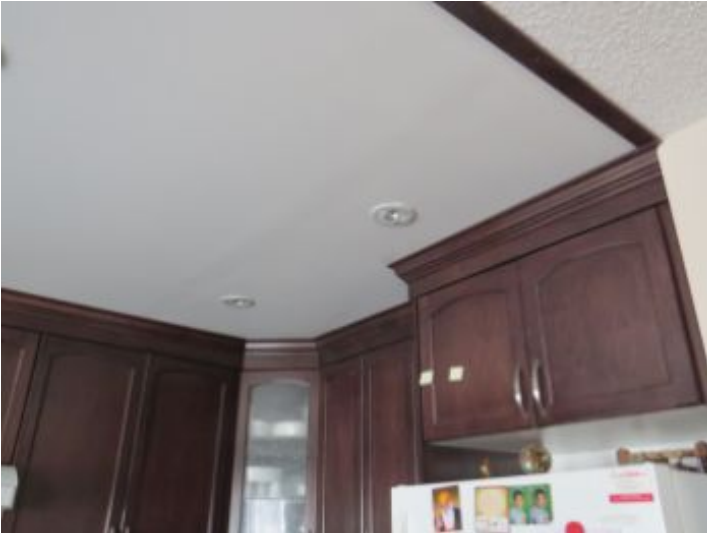
- There is extensive ceiling blemishes/damage that requires repair & repainting.

Ceiling blemish

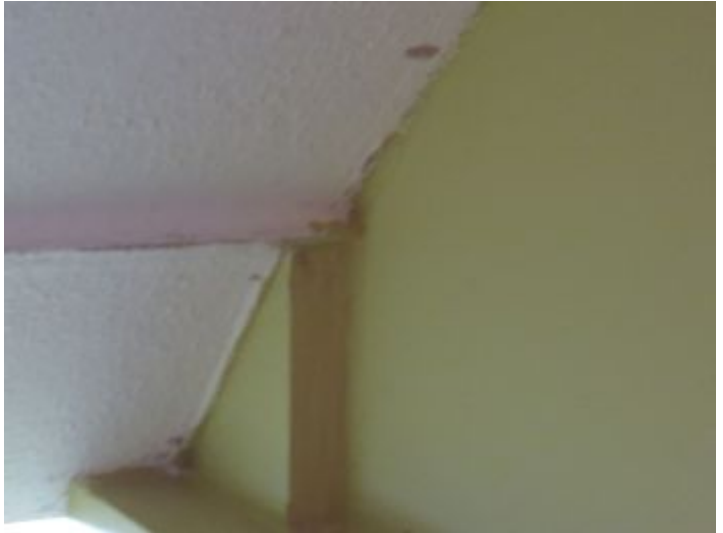
Interior blemish

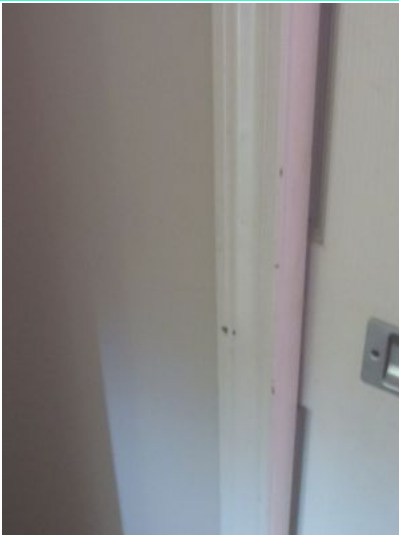
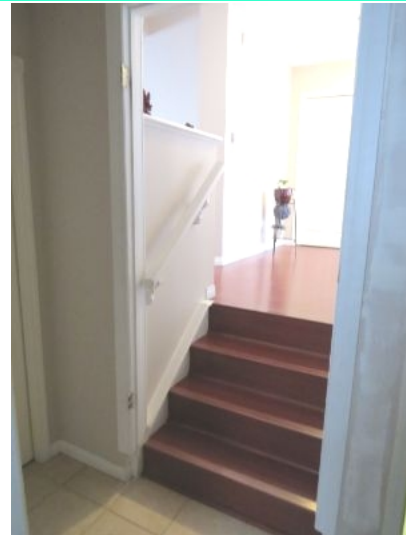
No door installed

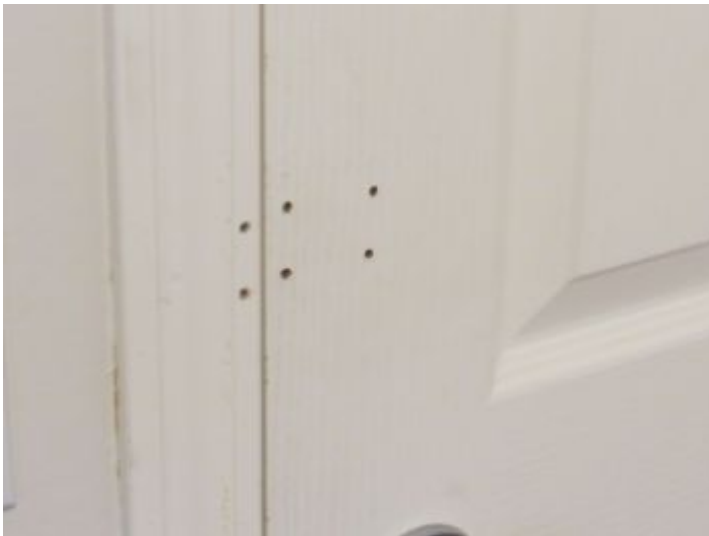
Repair as required

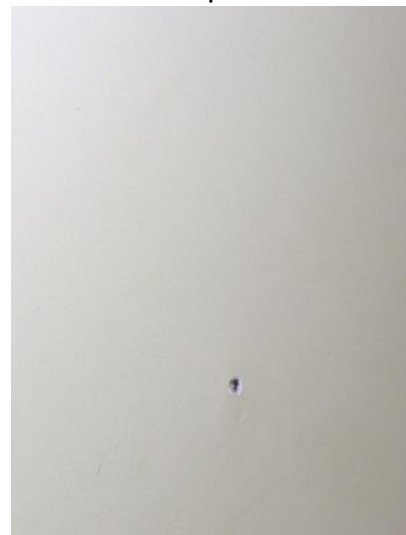
Wall blemish

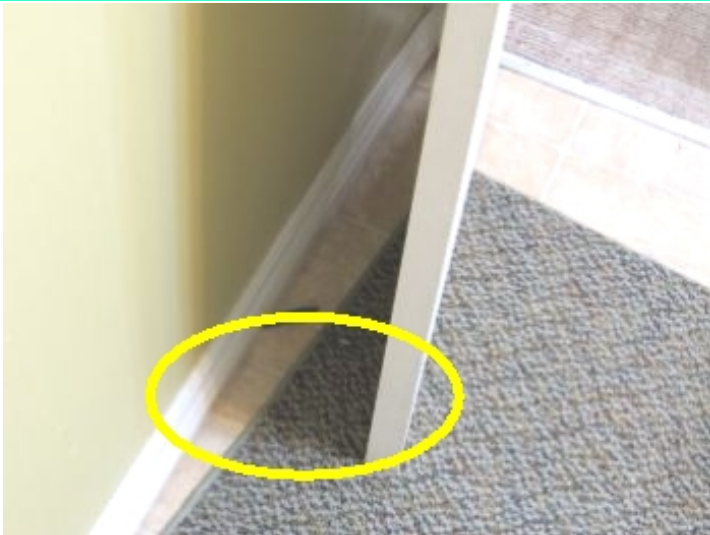
- Some room doors require painting.
- To avoid door hardware damage to walls insure doorstops are installed on all doors.
- As a life/safety concern locks on bedroom(s) door must be openable from the exterior of the room.

Install door stop

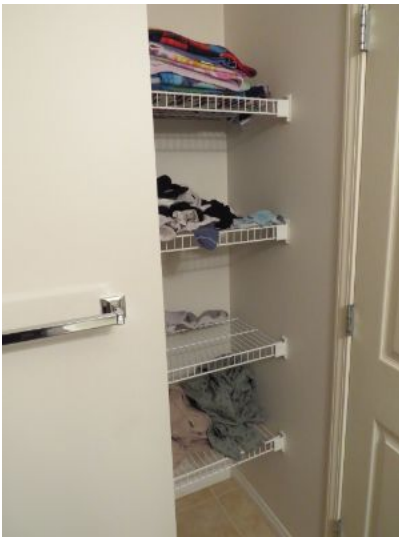
No closet door

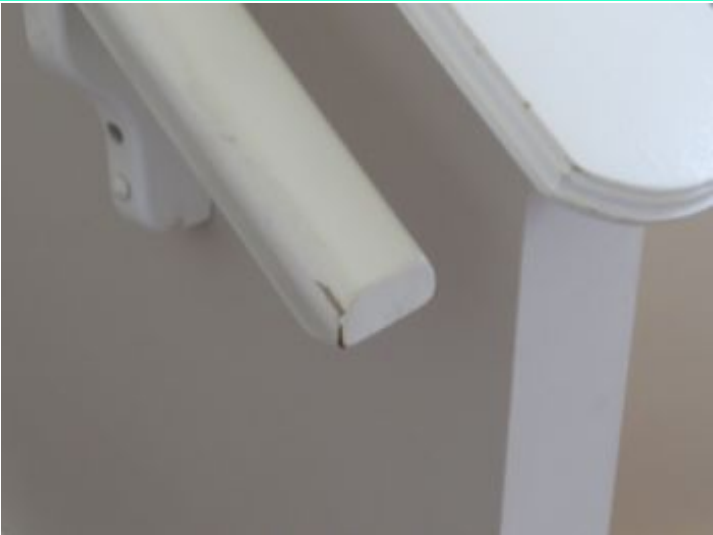
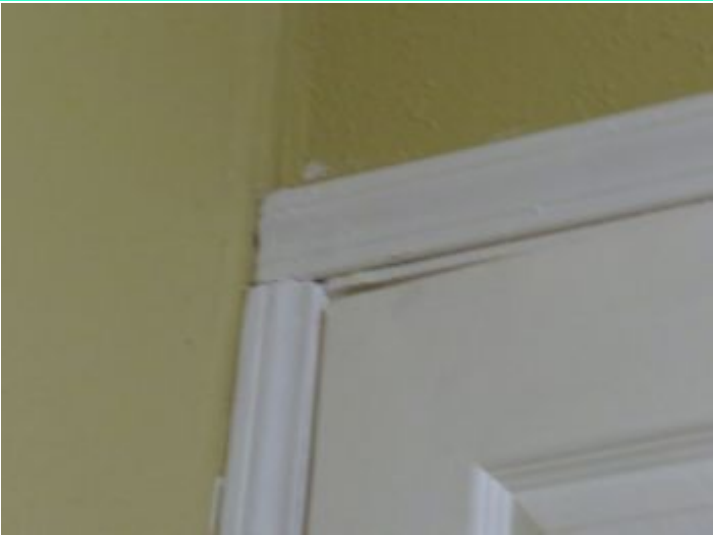
- The trim is original to the building & in some areas should be repaired & re-finished.

Poor installation

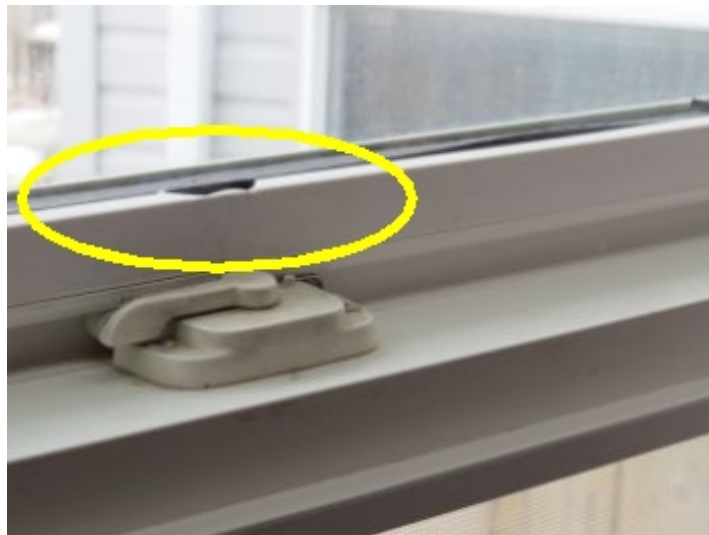
Minor window damage

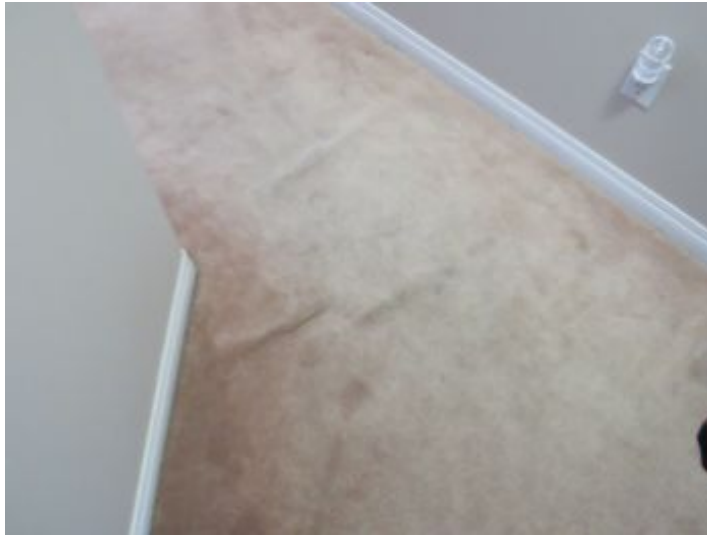
- The carpet is dirty & it is recommended to have the flooring professionally cleaned at move-in.
- There are some carpet "ripples". Have a professional carpet installer re - stretch.
- Stored personal items & furnishings limited a complete wall and floor inspection.

Carpet ripples

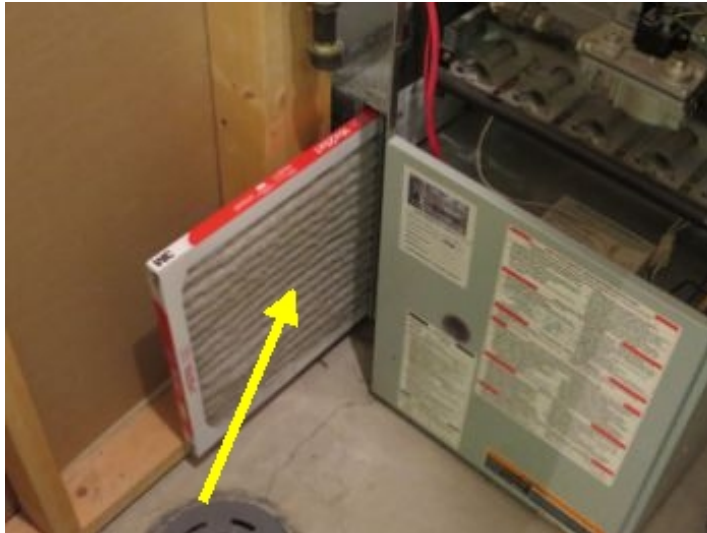
- "Slide in Out" type filter located at the lower bottom side of the furnace.
- For optimum furnace operation filters must be changed on a monthly bases or as recommended by the furnace and filter manufacturer. Clean filters extend the furnace life and improve operating efficiency.
- The "arrow" on all filters must point towards the furnace when installed (filter) properly.
- **The furnace filter is dirty & must be cleaned or replaced.**

Filter is dirty

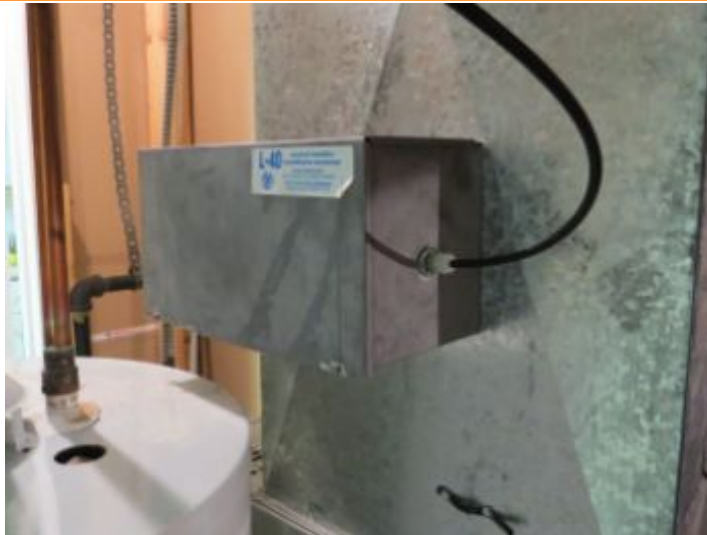
- With exposed wood flooring it is recommended that building humidification be installed.
- If a humidifier is required a "flow through" design is recommended.
- For proper operation the humidifier must be cleaned/serviced on a regular bases as recommended by the manufacturer. We recommended at least each year.
- The installed humidifier does not function.

Does not function

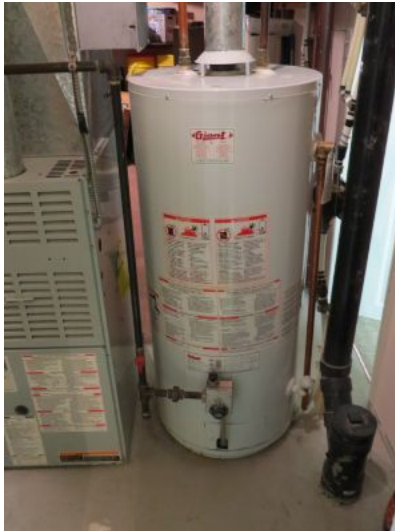
1. Hot Water Tank Recommendation

- At the time of inspection the hot water tank functioned.
- Hot water tanks have a design life of eight to twelve years.
- Over time sediment accumulates in a tank and reduces efficiency. Flushing twice a year is recommended.
- To save energy and fuel costs reduce the heat to the lowest operational temperature.
- When away from the dwelling for longer than two days reduce the heat level to "vacation" level.
- When replacing tanks consider tankless units or high efficiency tank. They both save energy costs.
- **The older hot water tank is beyond its design life and will need replacement.**

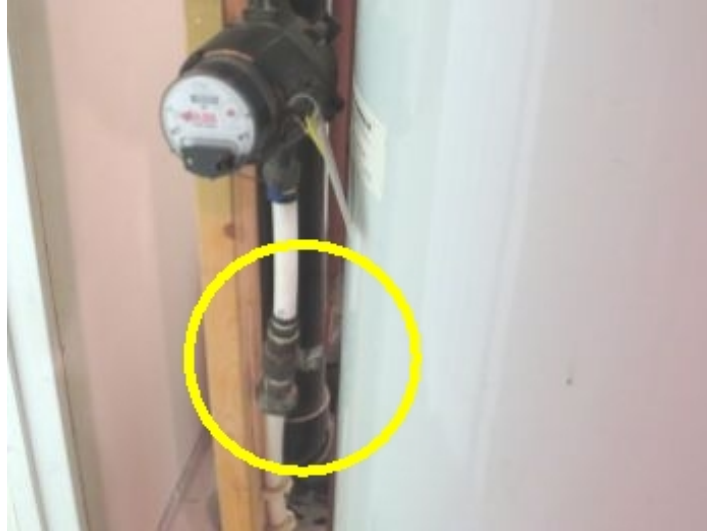
Main water shut off

- The water meter & main water shut - off is located near the hot water tank.
- Municipal, metered water supply.

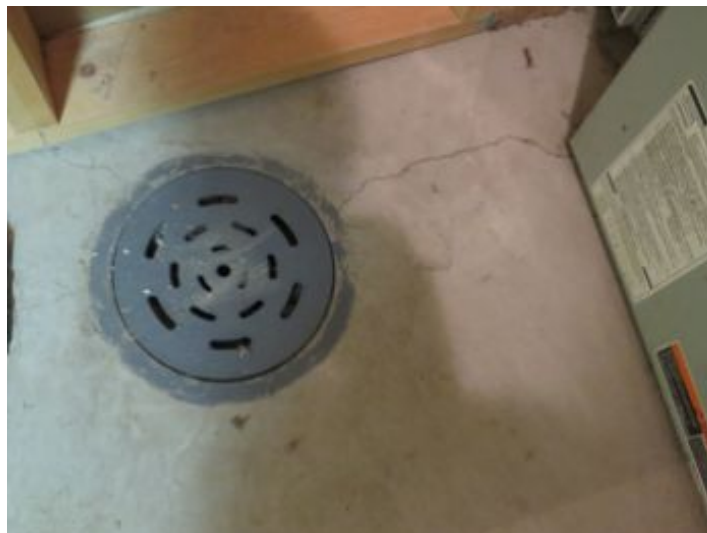
2. Basement Floor Drainage.

- At the time of inspection there was no major concerns with the basement floor drain.
- The floor drain should be cleaned on a regular bases.
- To stop sewer gases entering the structure, keep water in the drain.

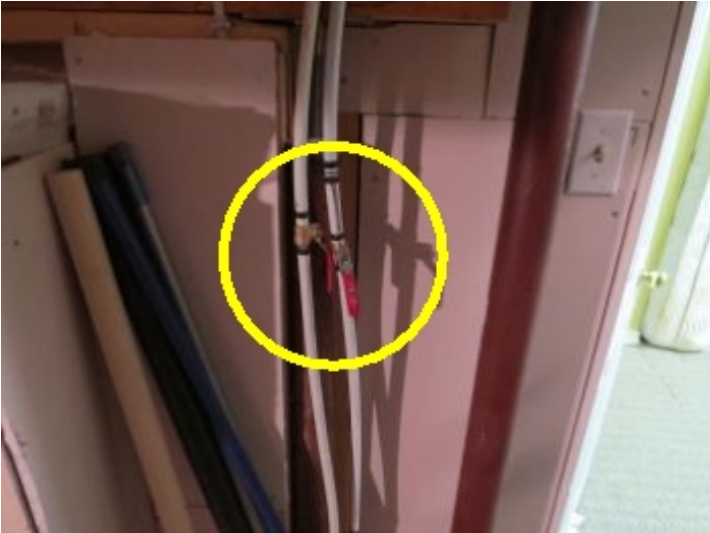
Exterior faucet shut off

- The installed water piping is P.E.X. (Cross-linked Polyethylene). No located leaks.

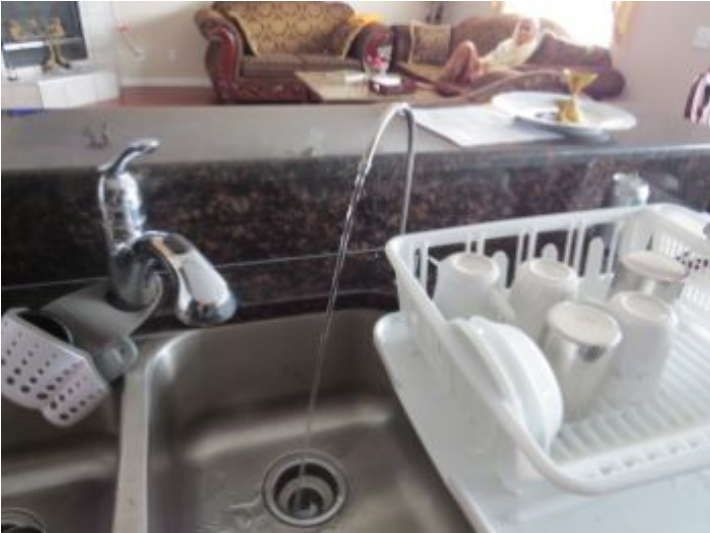
Filtered water

- The kitchen water filter functioned. Operate & change filters as required by the manufacturer.

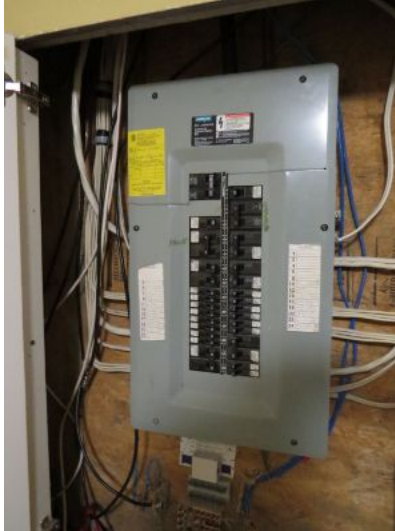
- Located at the east side of the dwelling.

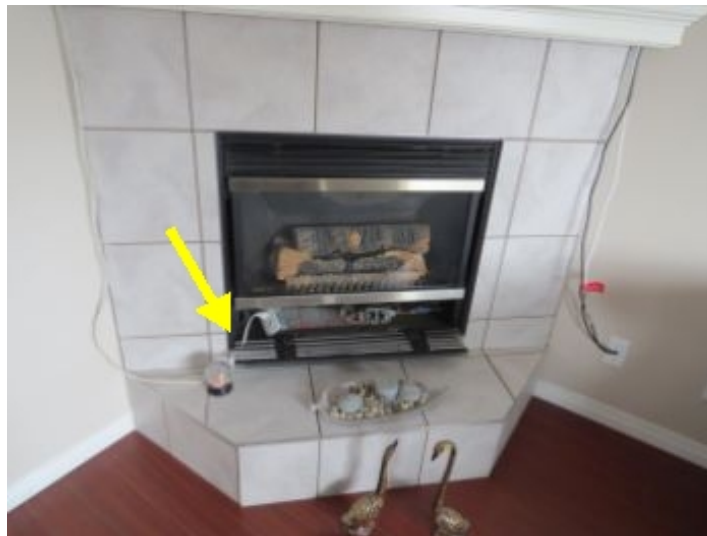
• There is an extension cord connected to the fireplace interior electrical fan outlet. There electrical cord is subject to heat from the fireplace & could fail & cause an electrical shock & must not be used. If required, have a correctly installed electrical outlet in the correct location.

Dangerous to use extension cord at this location.

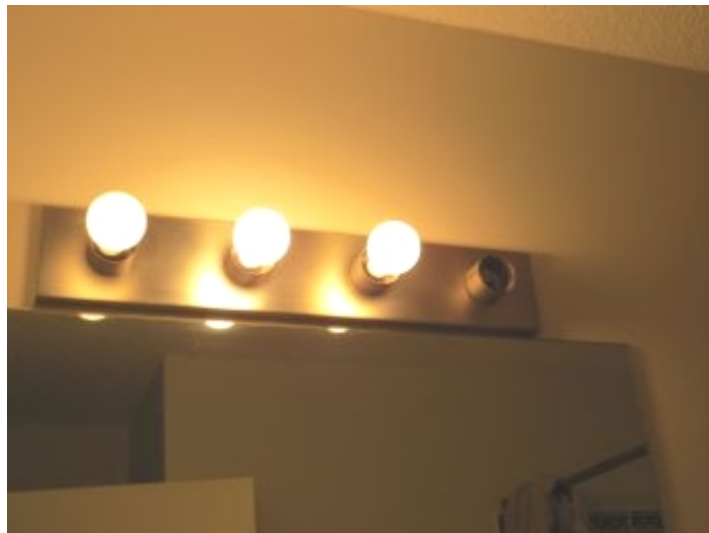
- At the time of inspection there was a number of missing/burned light bulbs.

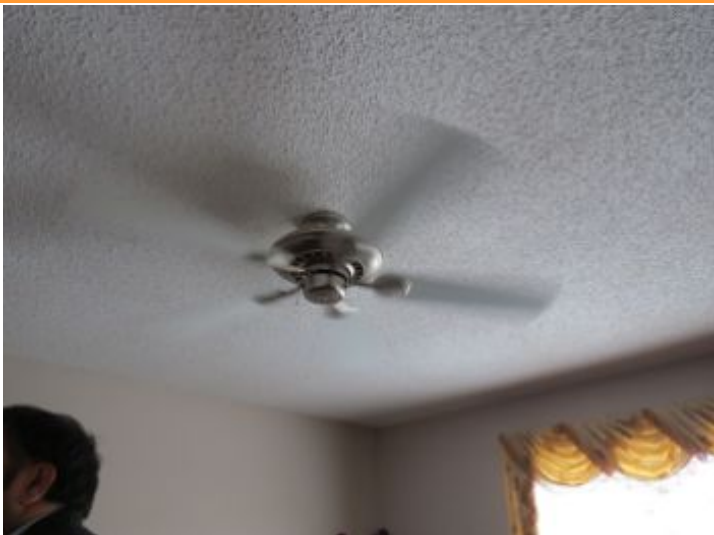
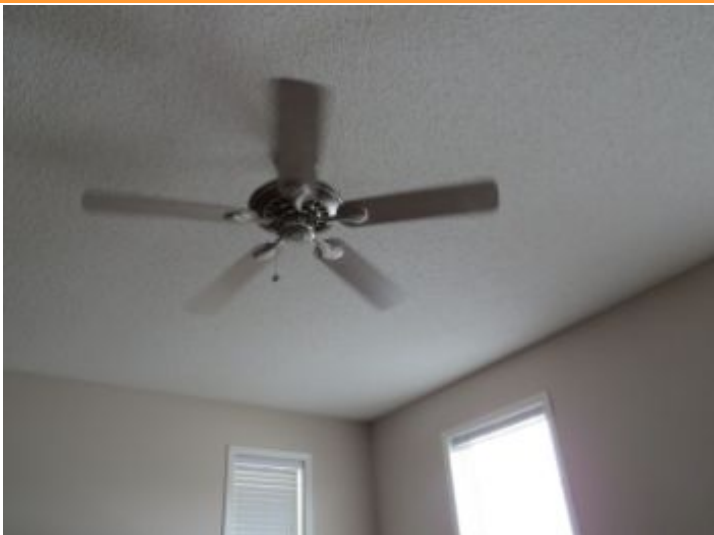
12. Ceiling Fan(s) Concerns.

- At the time of inspection the ceiling fan(s) functioned.
